January 13, 2017

CCR Annual Inspection

Ash Pond

A.B. Brown Generating Station

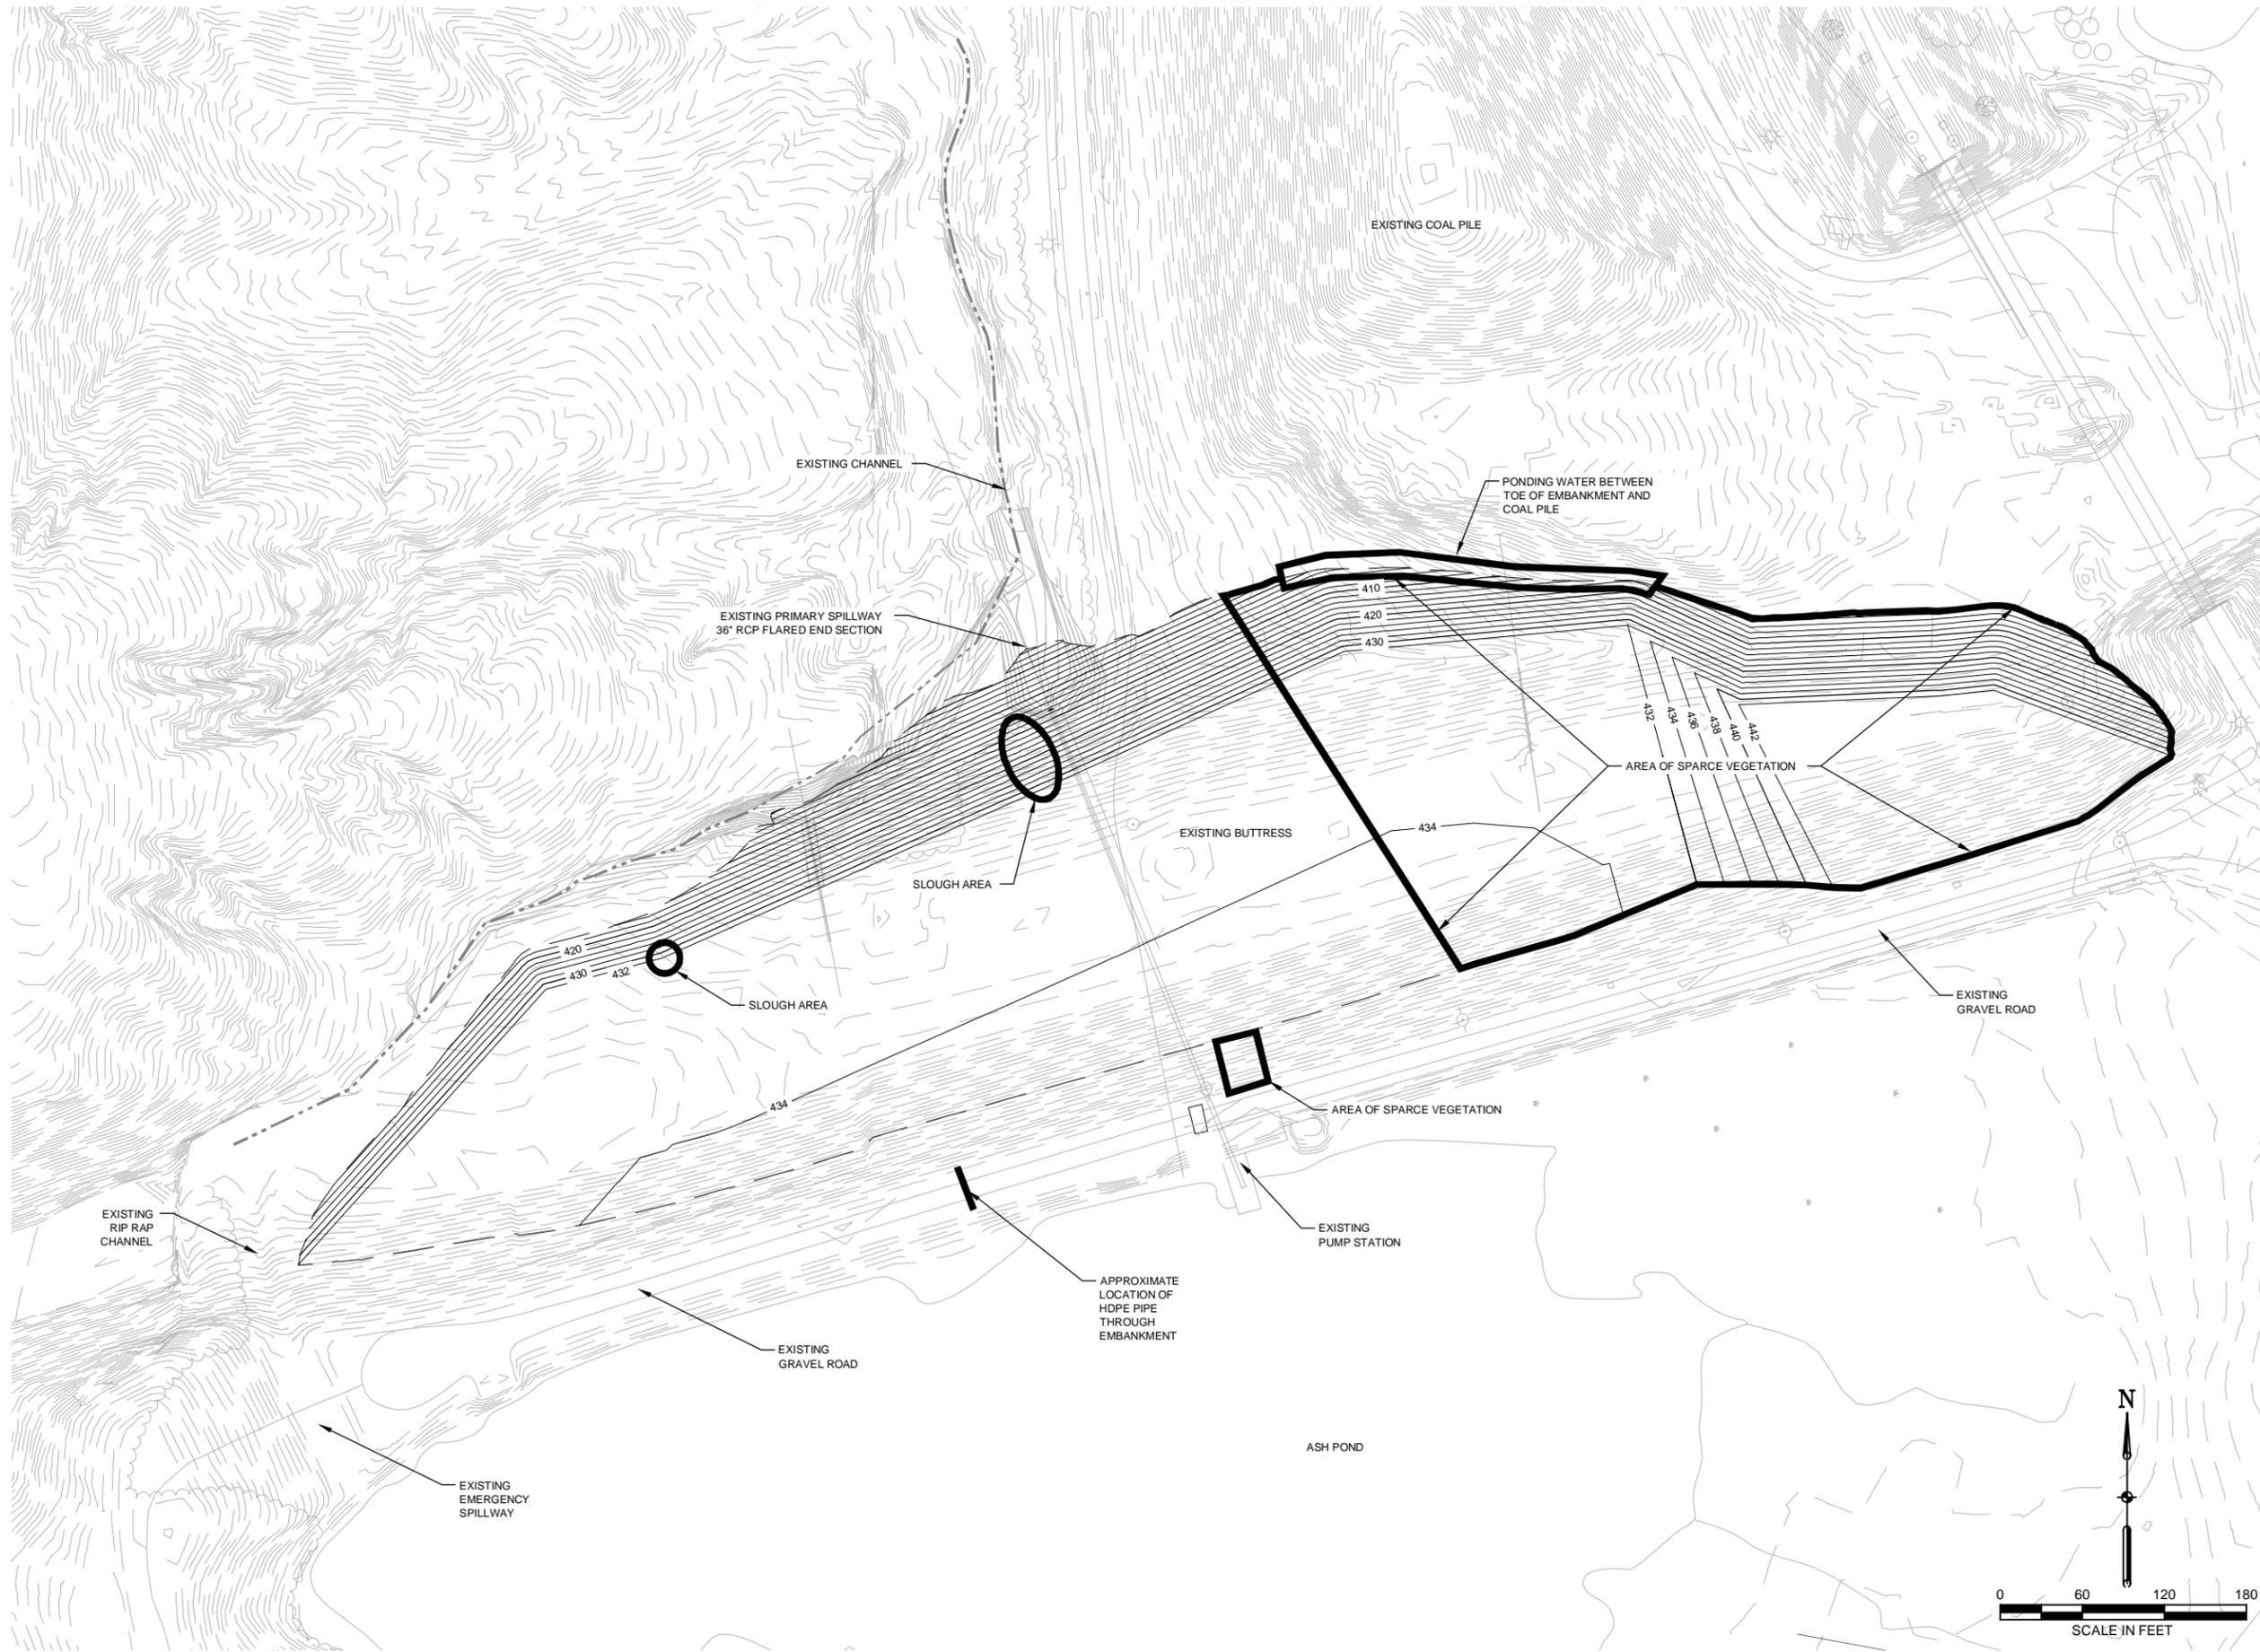
FIGURE 3

Deficiency/Observation	Proposed Corrective Measure
Phragmites were present at the toe of the interior slope below the rip-rap cover.	Spray as necessary to eliminate phragmite growth.
Small potholes/ruts were present at the crest.	Fill and regrade potholes/ruts as necessary.
The swale between toe of embankment and coal pile has ponding water areas.	Regrade swale to create positive drainage towards outfall to eliminate ponding water.
Silt was observed in the primary spillway's concrete flared end section at the toe of the embankment. This may have been residual silt from the recent buttress construction.	Flush silt from outlet pipe and monitor pipe for future silt deposits.
Sloughing was observed in two areas of the recently constructed buttress. See attached plan for locations.	Regrade and reseed areas this new construction area.
Sparse vegetation was observed in areas of the recently constructed buttress. See attached plan for locations. Vegetation is required to prevent erosion of soil material.	Reseed areas these newly planted areas.

An abandoned section of pipe passes through the top of the embankment just under the access road.	Vectren has left this section of the pipe in place for future use. No action necessary as the pipe is above the peak water surface elevation of the inflow design storm. Monitor for potential erosion around pipe.
