January 10, 2018

CCR Annual Inspection

Ash Pond

A.B. Brown Generating Station

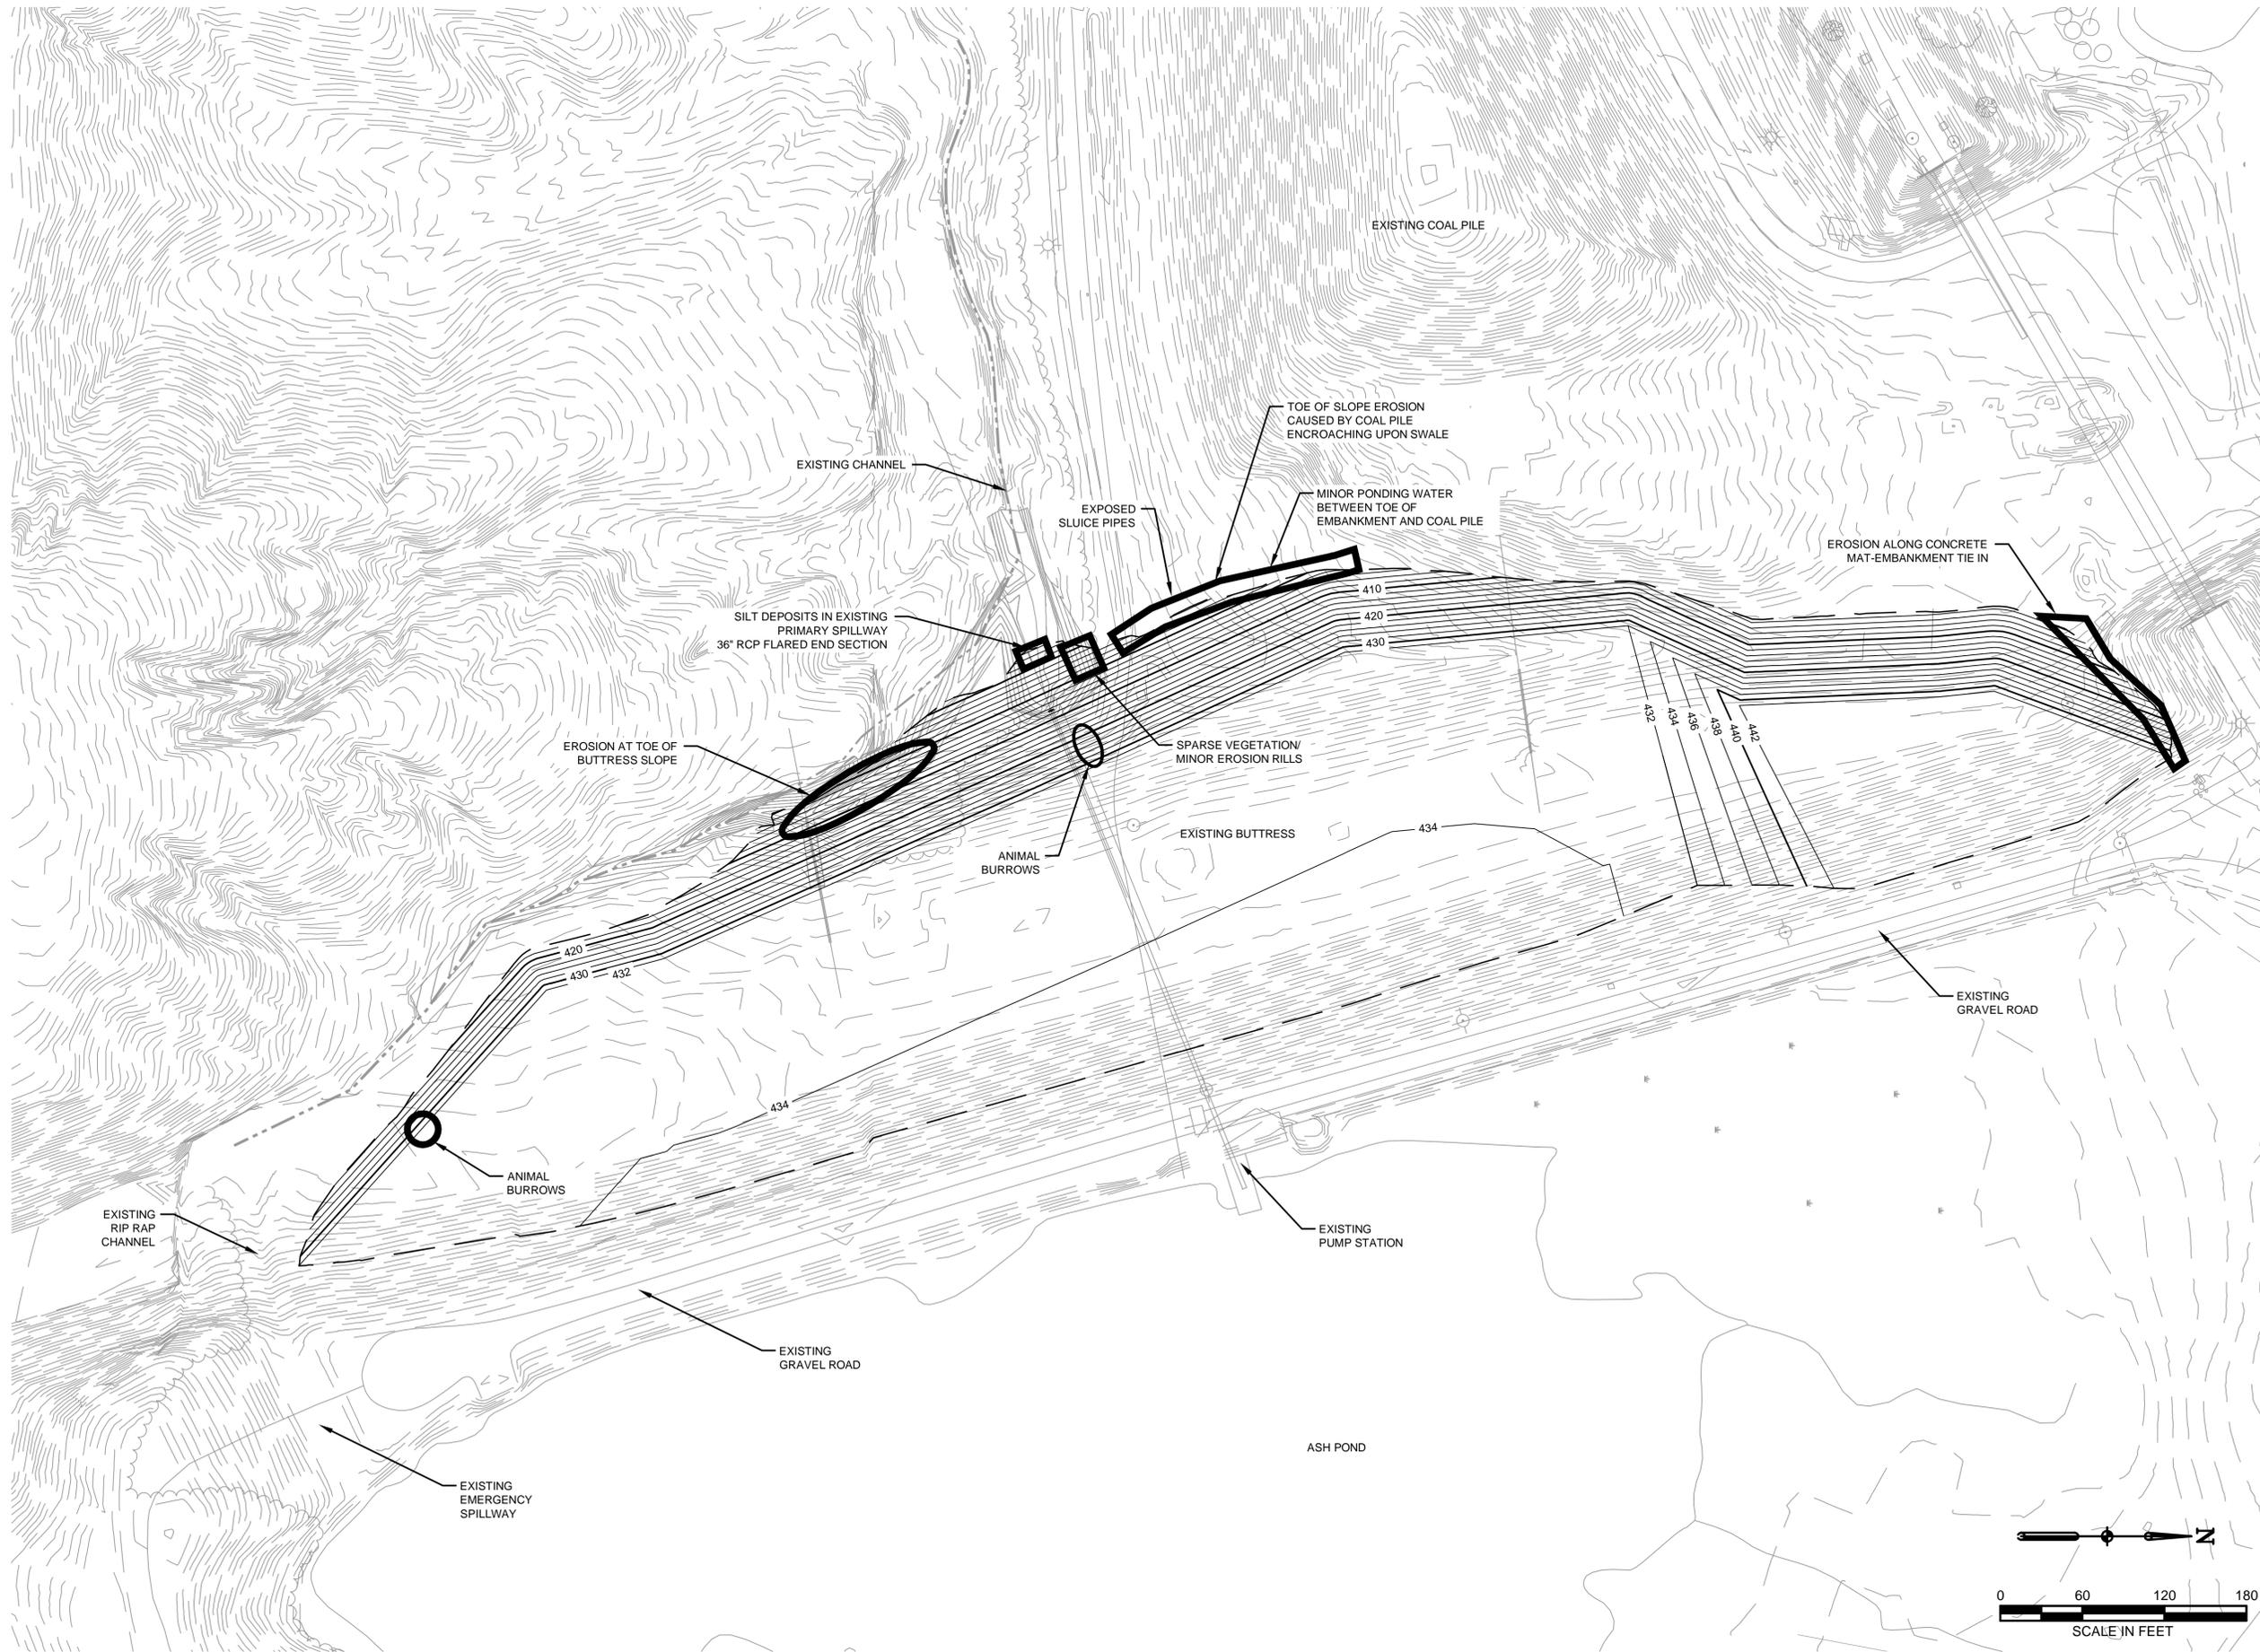
**FIGURE 3**

Sloughing was observed in two areas of the recently constructed buttress. See attached plan for locations.	Areas along the buttress that had sloughing were regraded and reseeded.
Sparse vegetation was observed in areas of the recently constructed buttress. See attached plan for locations. Vegetation is required to prevent erosion of soil material.	Reseeding has been done and ample vegetation is present in the areas of the constructed buttress.
An abandoned section of pipe passes through the top of the embankment just under the access road.	Vectren had left this section of the pipe in place for future use. As detailed in the previous annual inspection, no action necessary as the pipe is above the peak water surface elevation of the inflow design storm. There is no erosion around the pipe.

Deficiency/Observation	Proposed Corrective Measure
Animal Burrows were present at the exterior edge of the buttress along the top of the outer slope. See attached plan for locations.	Fill with compacted soil and regrade as necessary. Regraded areas shall be seeded with vegetation.
Silt was observed in the primary spillway's concrete flared end section at the toe of the embankment.	Flush silt from outlet pipe and continue monitoring pipe with video inspections for deficiencies or future silt deposits.
Erosion was observed where the concrete mats tie into the embankment on the north end of the buttress. See attached plan for locations.	Regrade and reseed these areas.
Erosion was observed at the toe of the embankment adjacent to the coal pile area. The coal pile encroaches upon the swale causing erosion along the toe of the embankment. This erosion has also caused two non-operational drainage pipes to be exposed above ground surface in addition to minimal ponding water.	Move Coal Pile away from the toe of embankment, and regrade and reseed eroded areas. Positive drainage shall continue to be maintained along the swale towards the outfall.

Sparse vegetation and erosion rills were observed in areas of the buttress's exterior slope. See attached plan for locations.	Reseed these areas. Mulching can be done if necessary.
