January 10, 2020

CCR Annual Inspection

Ash Pond

A.B. Brown Generating Station

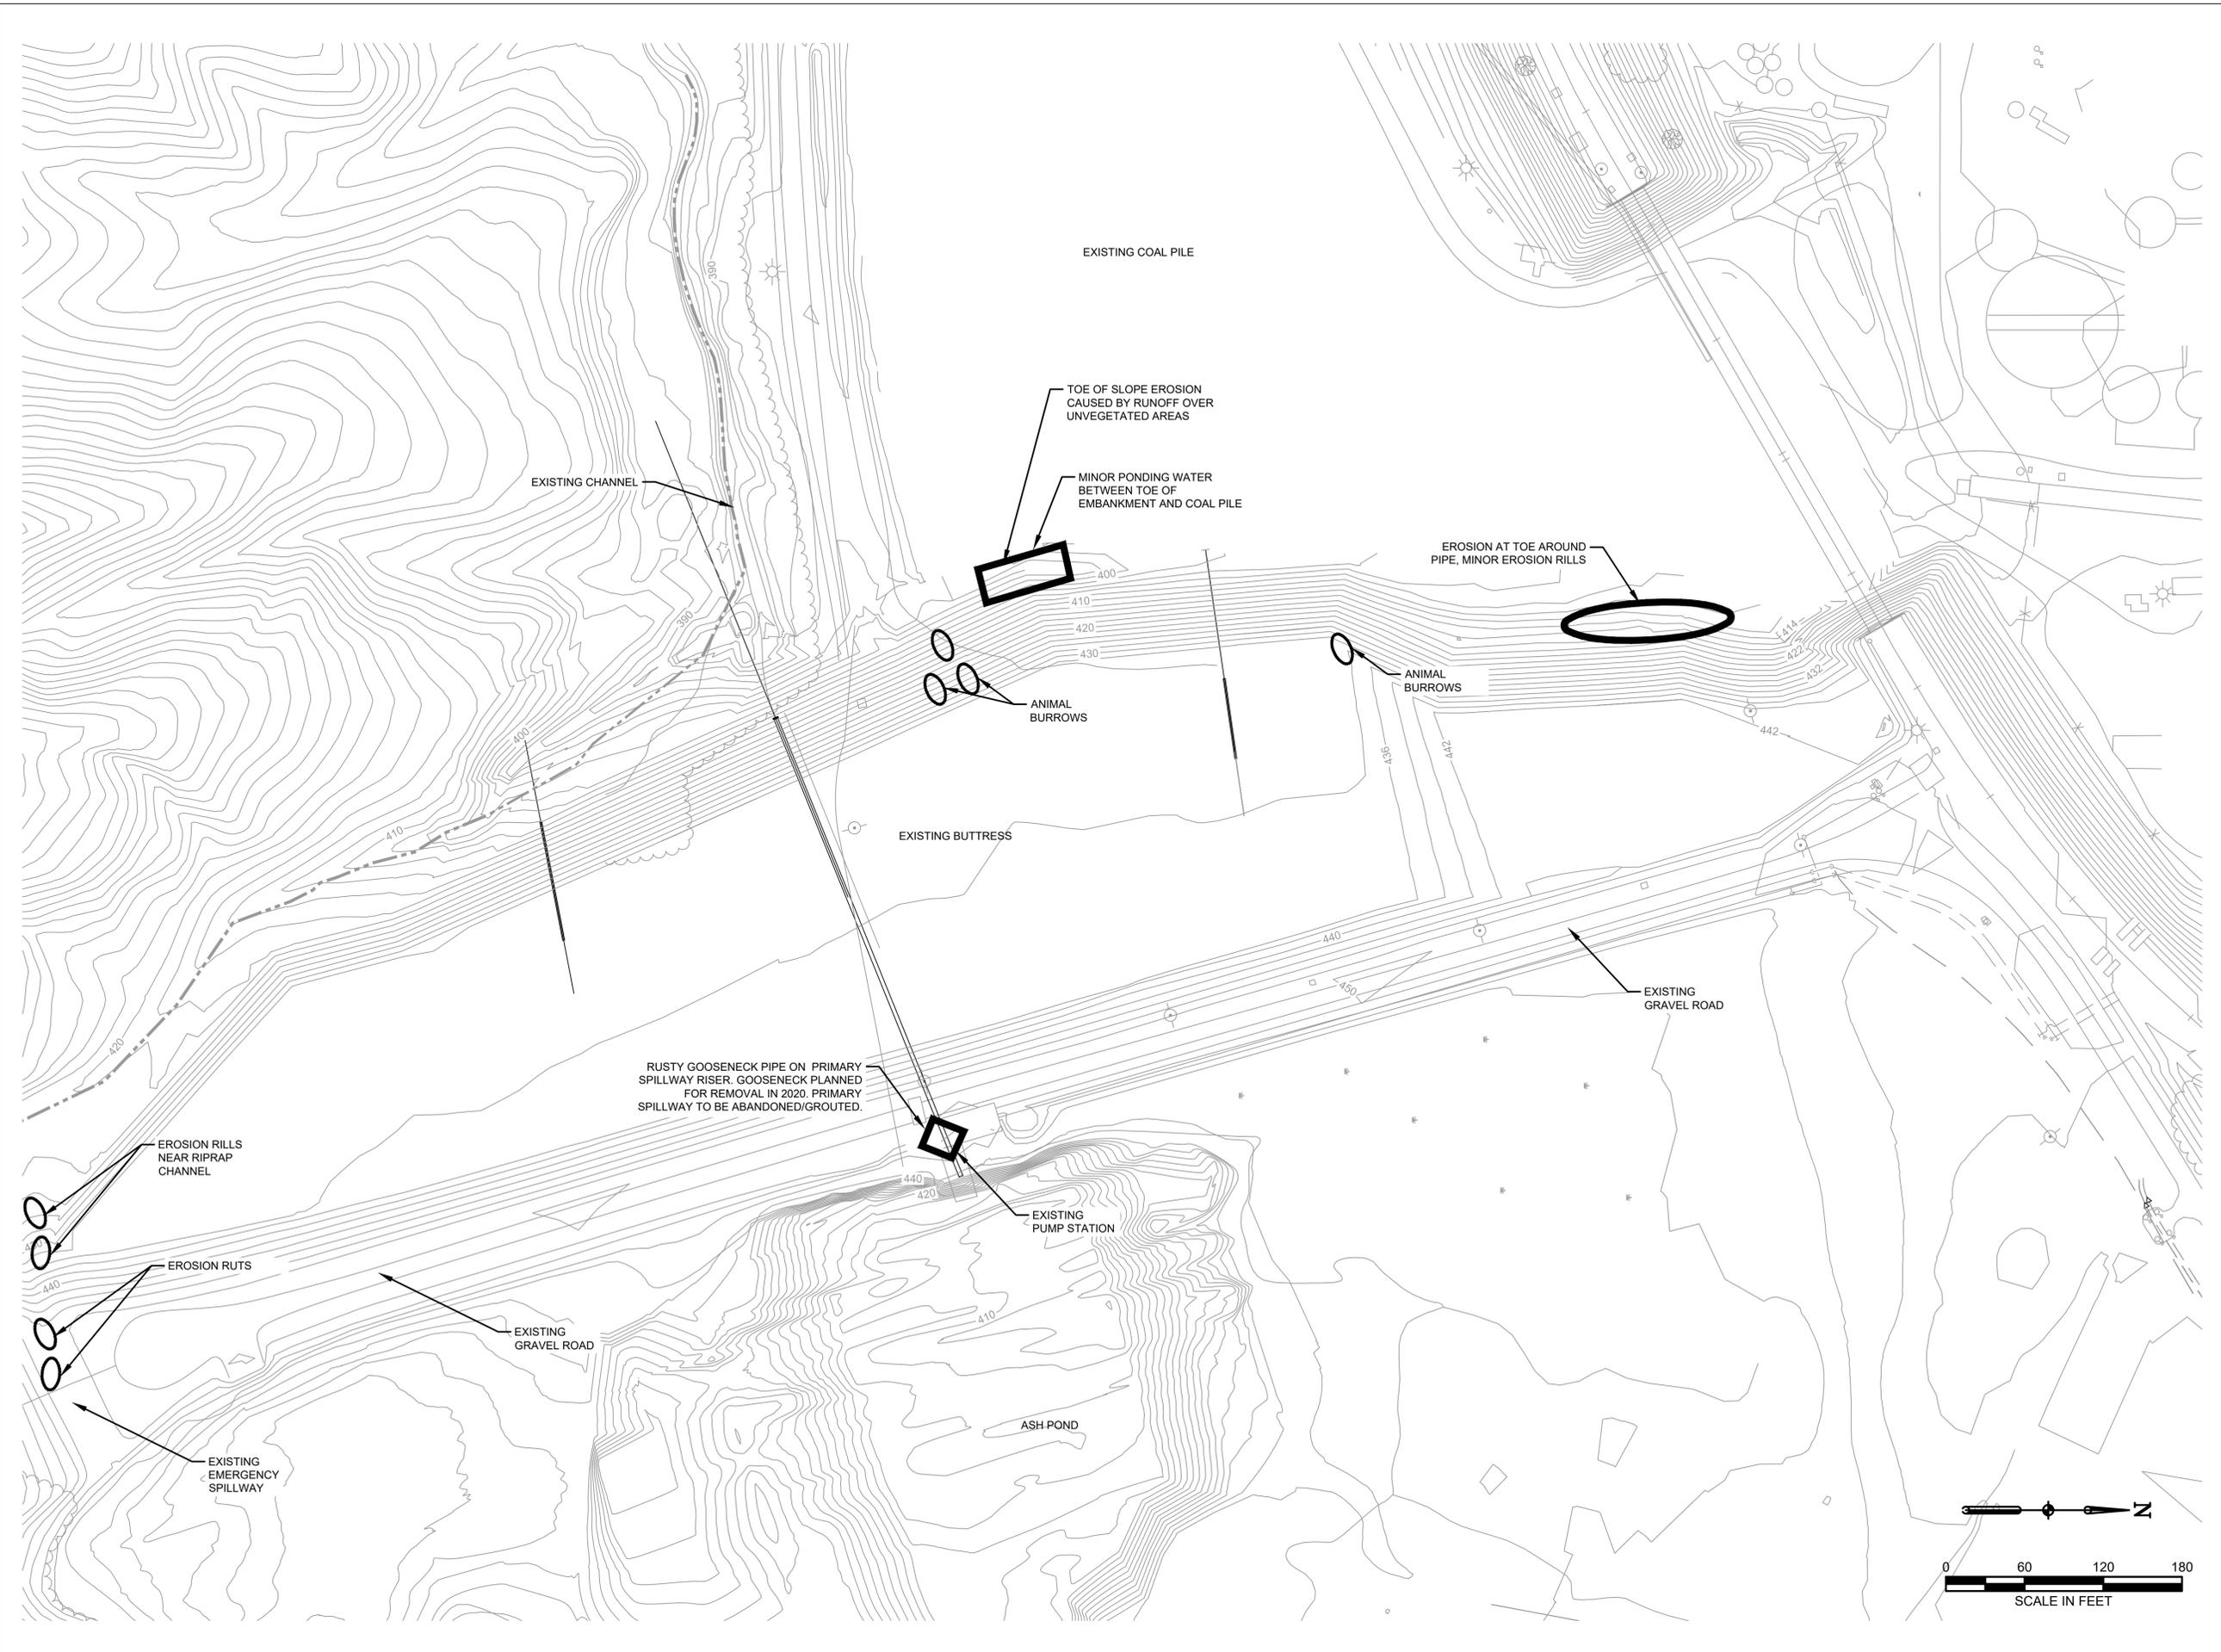
FIGURE 3

Deficiency/Observation	Proposed Corrective Measure
Isolated erosion ruts along the southern crest of the embankment.	Backfill the ruts and compact backfill as required. Backfilled areas shall be seeded with vegetation.
Moderate erosion has developed adjacent to the riprap protection along the southern toe of the buttress.	Seed and mulch as necessary. Continue monitoring to ensure adequate vegetation is present.
Small animal burrows were present at the exterior edge of the buttress along the middle of the outer slope. See attached plan for locations.	Fill with compacted soil and regrade as necessary. Regraded areas shall be seeded with vegetation.
Moderate erosion exists around the end of the surface water diversion outlet pipe at the northern toe of the buttress.	Fill with compacted soil and regrade as necessary.
Gooseneck pipe on riser of primary spillway is rusty.	Gooseneck is planned for removal in 2020 and primary spillway will be abandoned/grouted.

Minor erosion was observed at the toe of the embankment adjacent to the coal pile area. The erosion has potential to promote minor ponding of water between the toe of embankment and the coal pile.	Regrade and reseed eroded areas. To prevent any future ponding between the coal pile and the toe of the embankment continue to maintain positive drainage along the swale towards the outfall.
