January 8, 2021

CCR Annual Inspection
§257.83 (b)

Ash Pond

A.B. Brown Generating Station

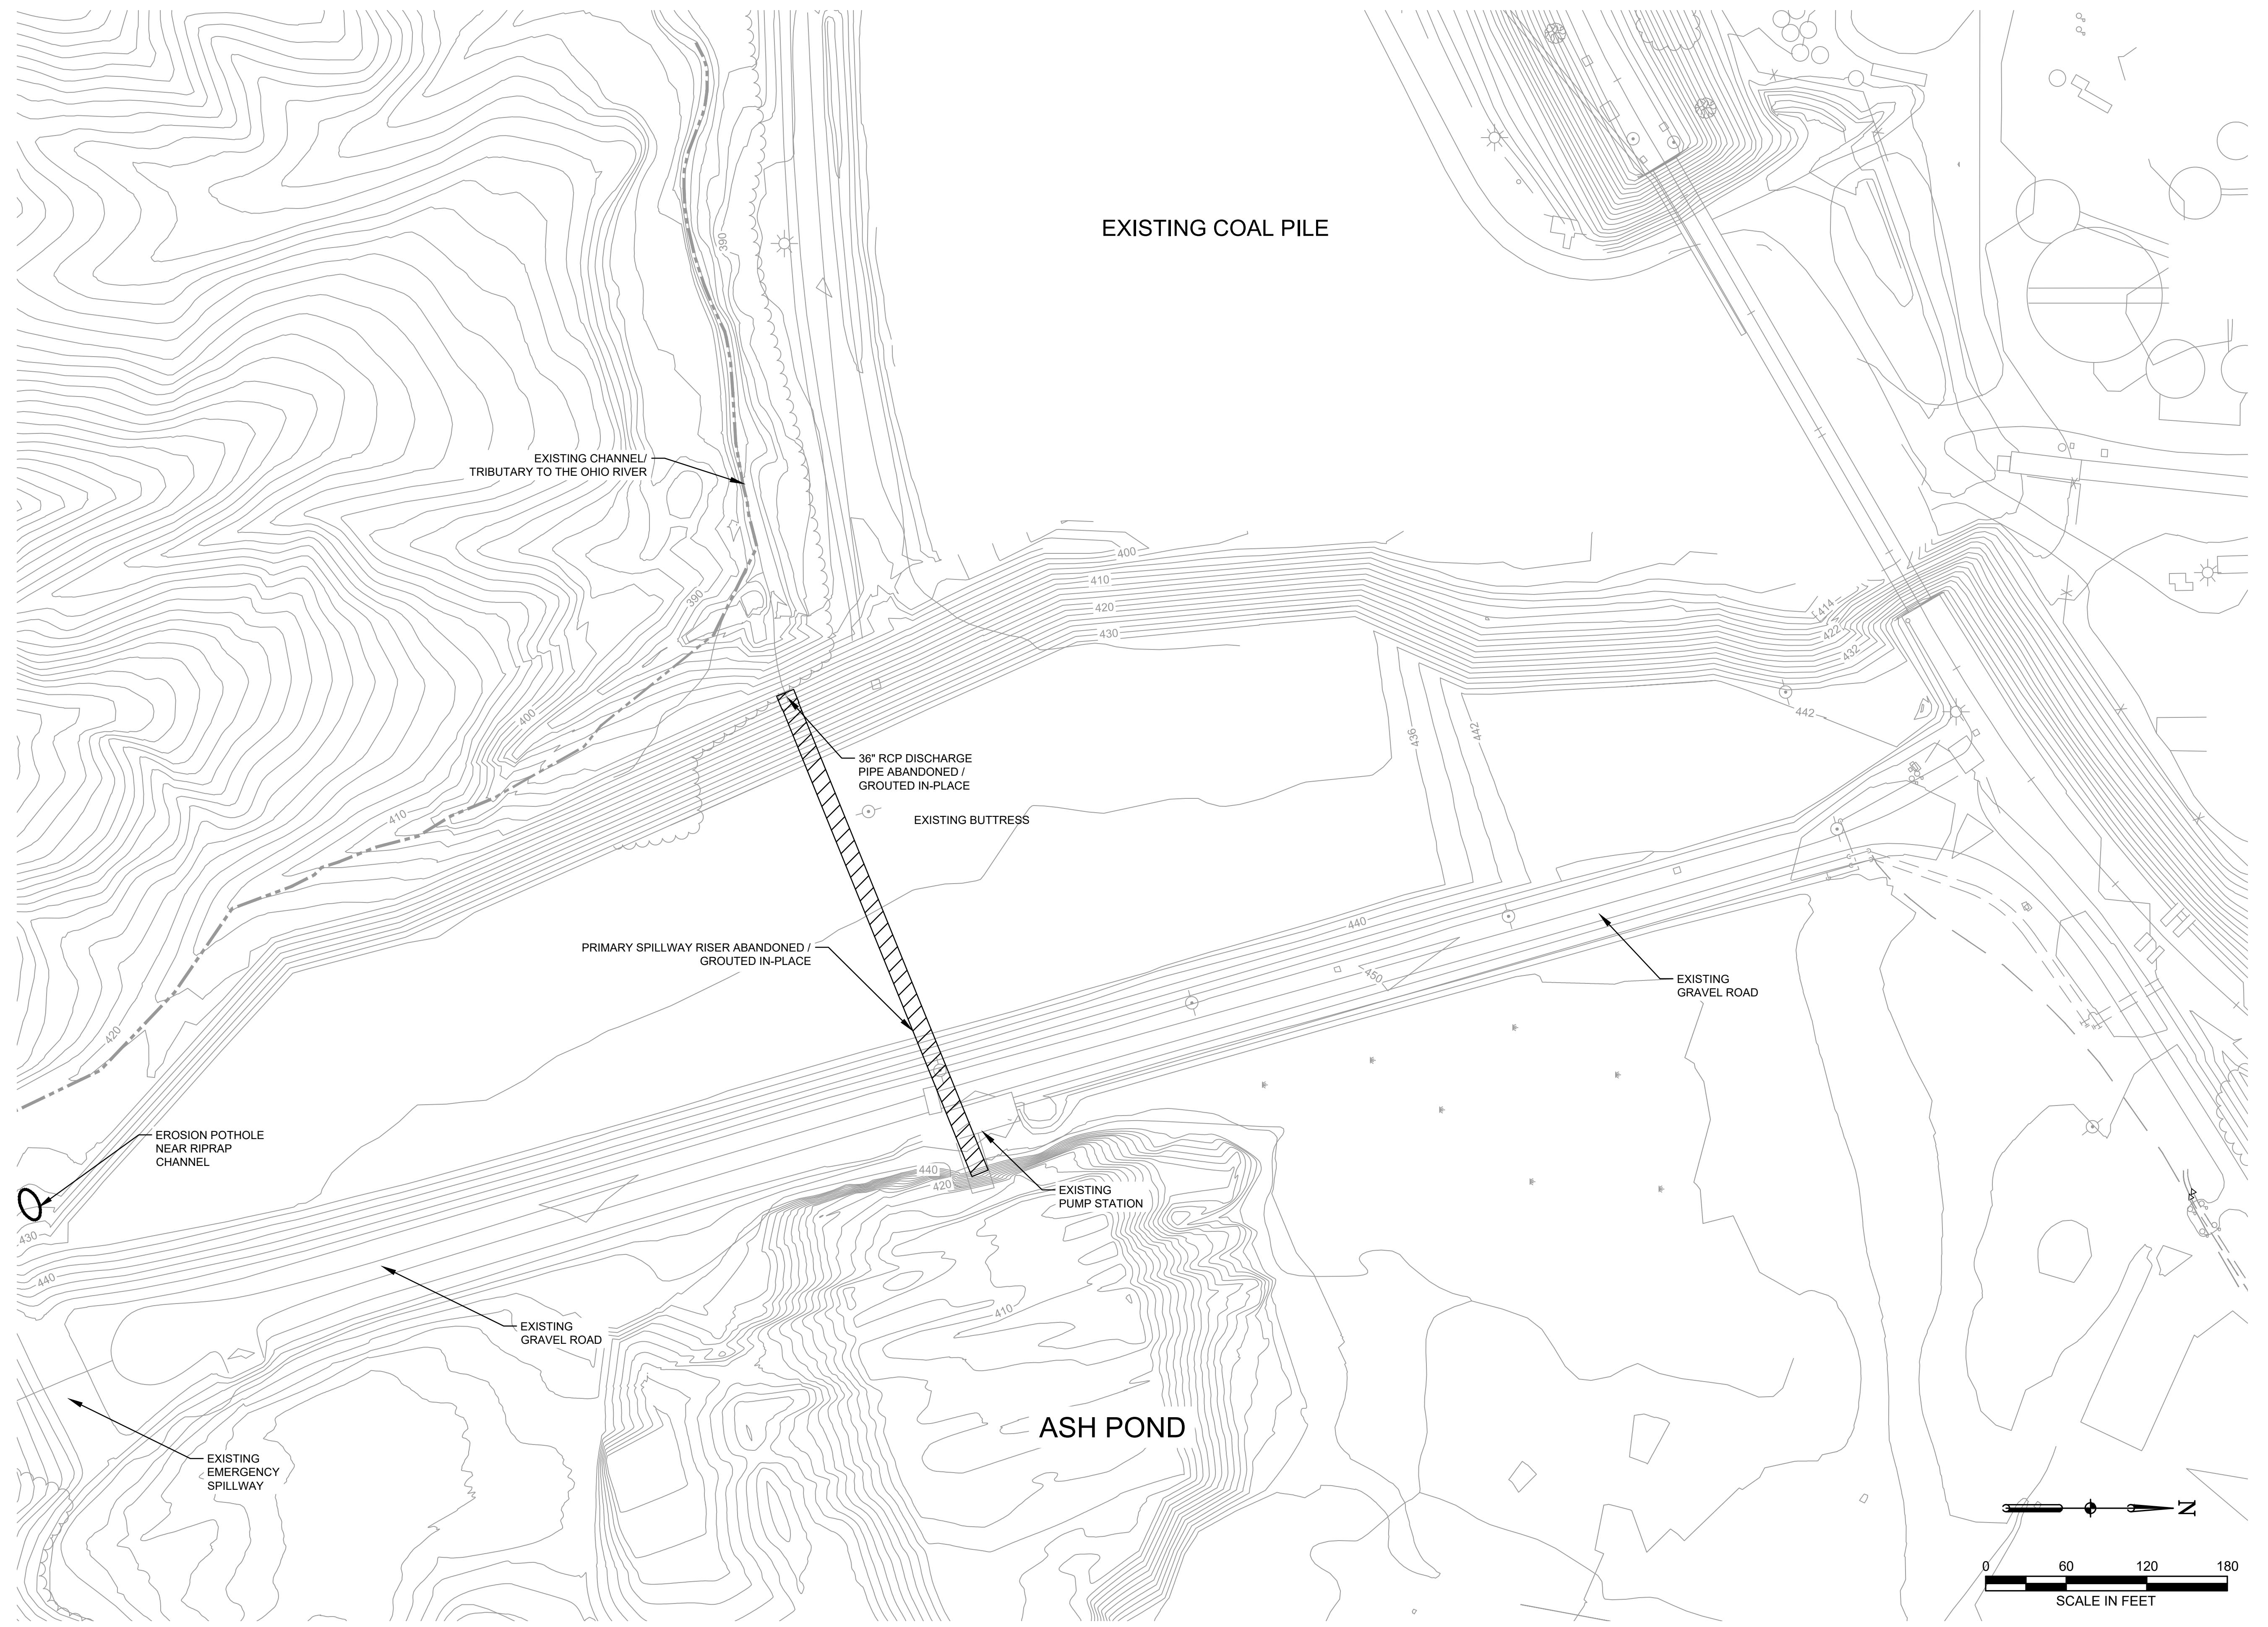
FIGURE 3

Ash Pond discharge metallic pipe is rusted with a small hole.	Discharge spillway including the pipe in concern have been abandoned as noted in the Site Inspection Plan (Figure 3).
Minor erosion was observed at the toe of the embankment adjacent to the coal pile area. The erosion has potential to promote minor ponding of water between the toe of embankment and the coal pile.	Coal from the coal pile area was moved away from the toe of the embankment as part of the routine maintenance. No erosion remains.

Deficiency/Observation	Proposed Corrective Measure
Minor potholing was observed at the edge of the riprap channel on the southern extent of the embankment. The pothole allows for stormwater runoff to flow underneath the riprap channel and has the potential to cause additional erosion along the channel edge.	Fill pothole with compacted soil or concrete. Place additional riprap and compacted soil along the edge of the riprap channel and re-grade as necessary to prevent flow from entering this area.
