VISUAL SITE INSPECTION REPORT - 2016

SOUTHERN INDIANA GAS AND ELECTRIC
A. B. BROWN GENERATING STATION
TYPE III RESTRICTED WASTE LANDFILL
WEST FRANKLIN, IN

ATC PROJECT NO. 170LF00318

DECEMBER 20, 2016

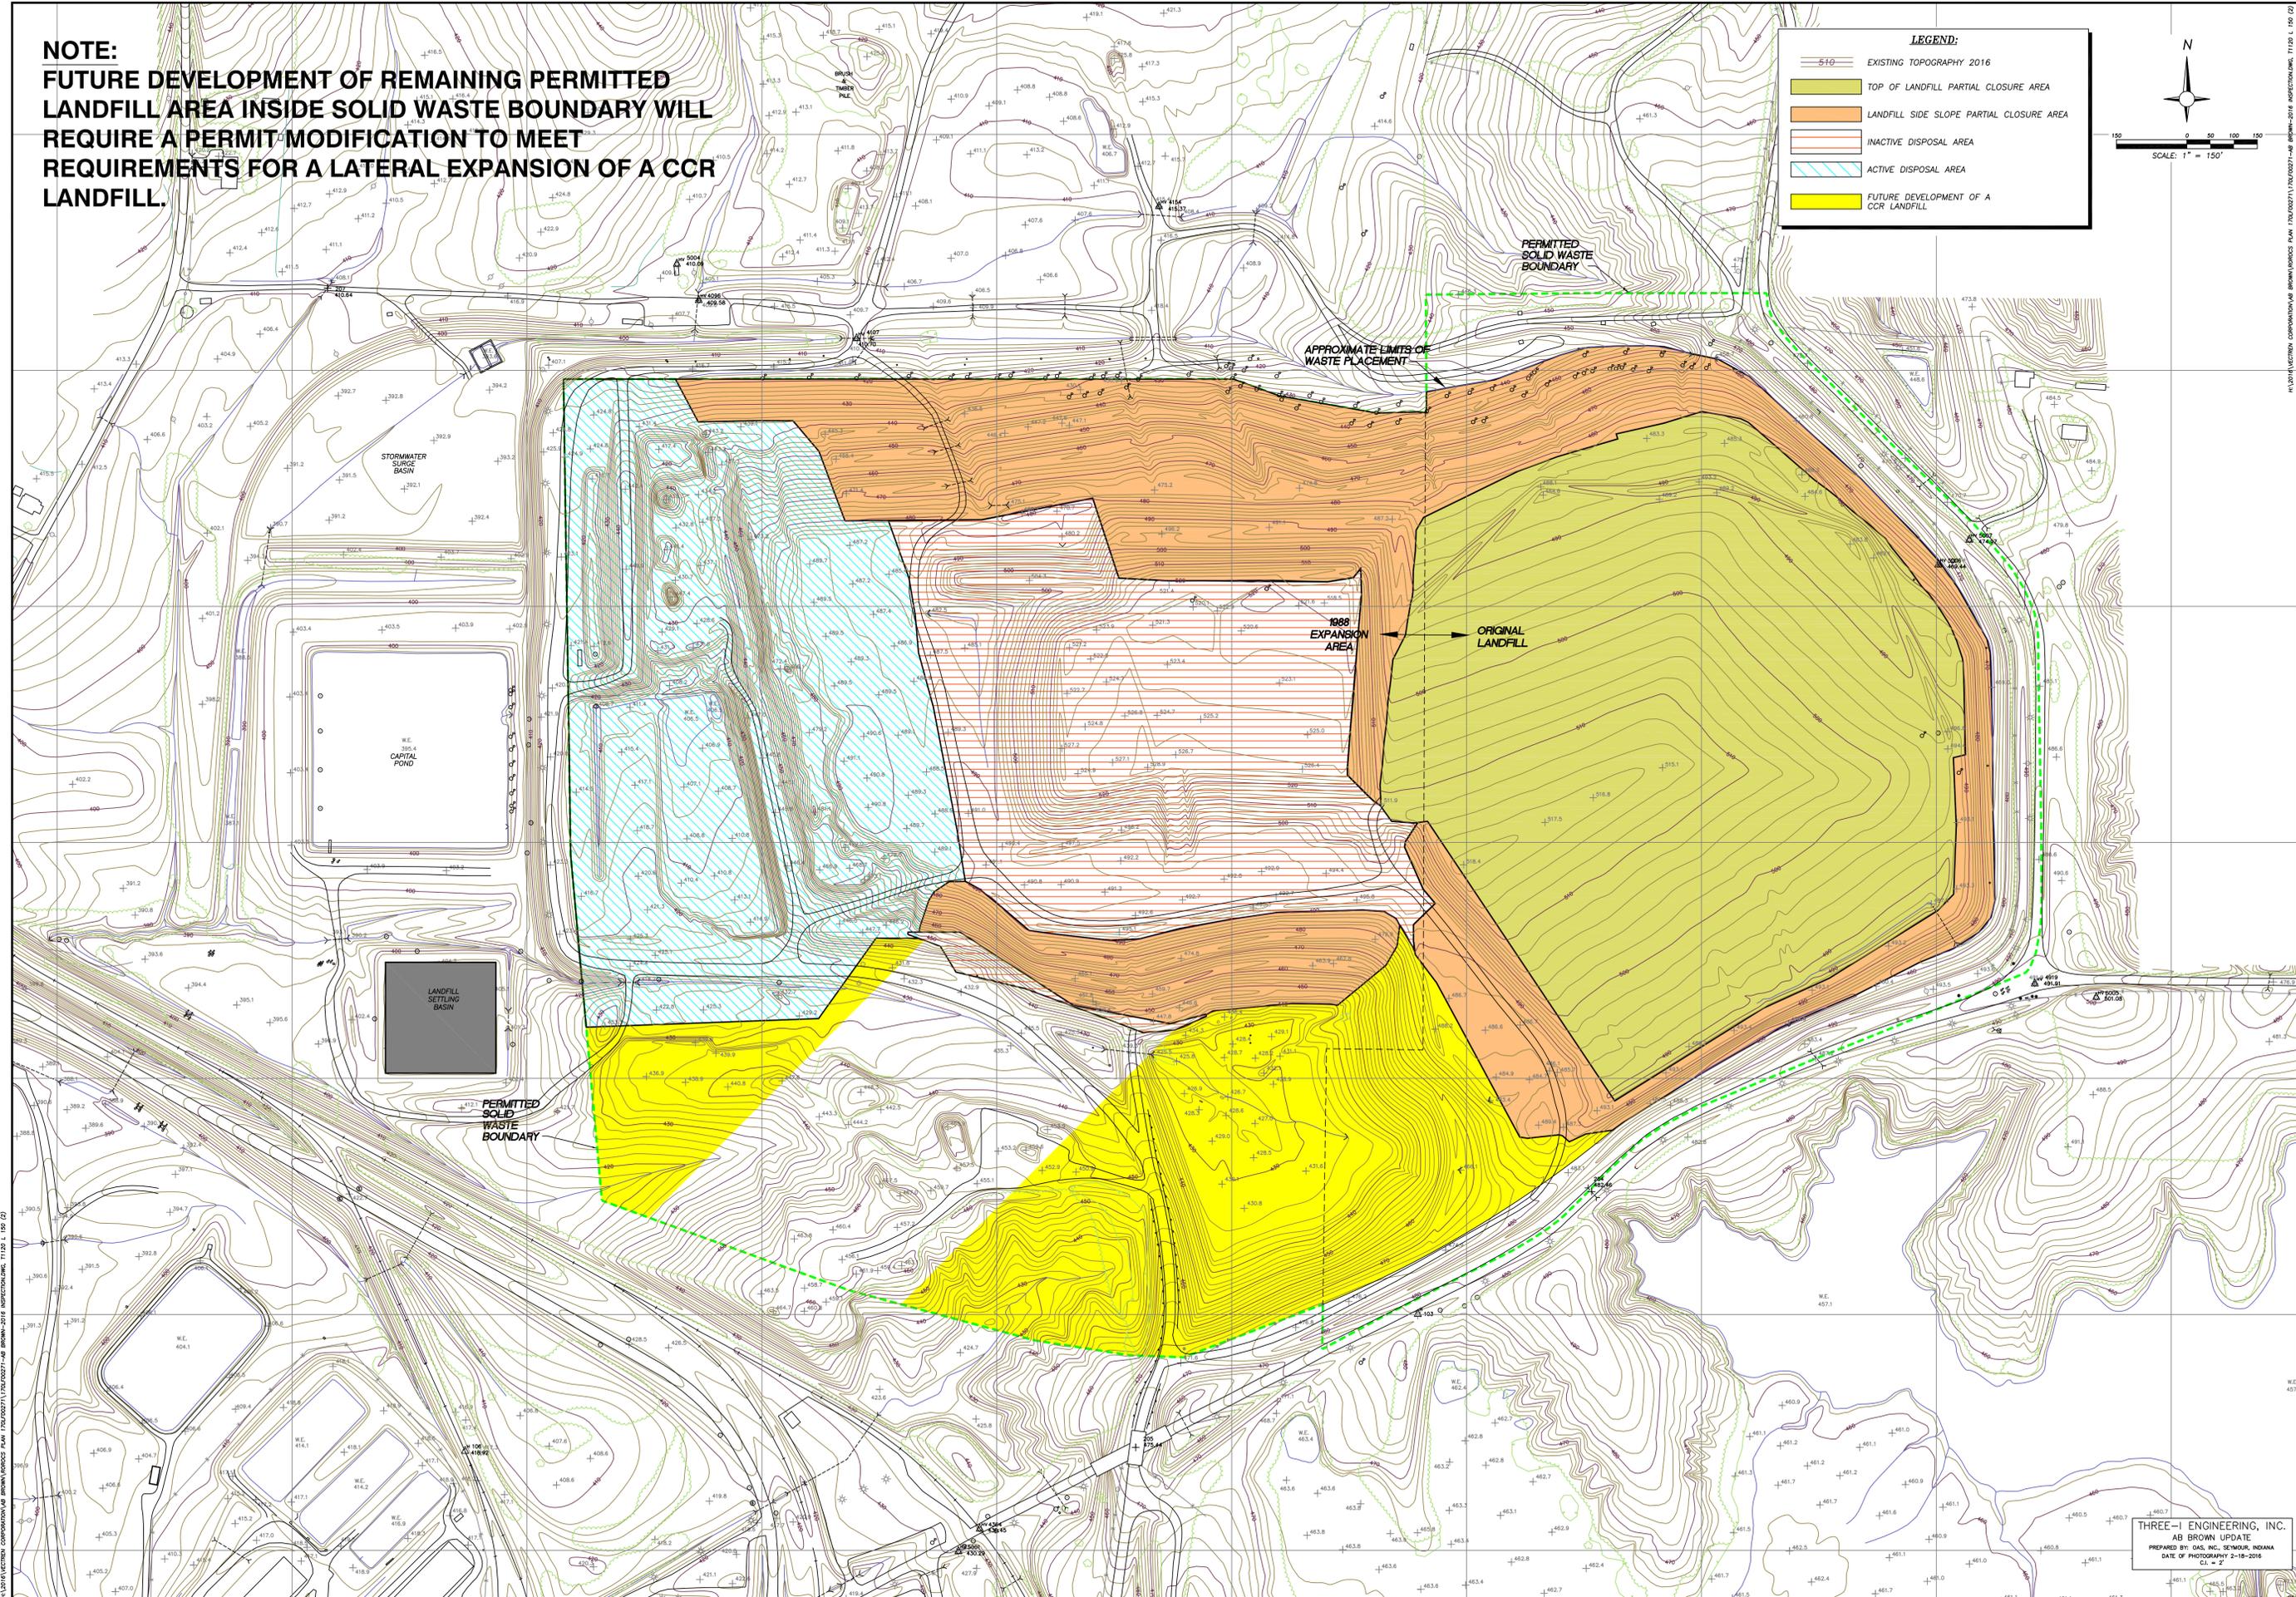
Drawing Title:	SITE PLAN A.B. BROWN GENERATING STATION
Sheet:	1

The approximate limits of each of these areas is noted on Sheet 1 in Appendix A. The following paragraphs include a summary of the observations made during the inspection followed by our recommendations in bold print.

The final cover on the perimeter slopes noted on Sheet 1 in Appendix A consists of a minimum of 24 inches of cohesive soils, covered with 0.5 ft of topsoil. The approximate limits of the 24.5 acre closed portion of the slopes is noted on Sheet 1 in Appendix A. Documentation of the completion of the closure activities along these slopes was submitted to IDEM in 2015. Items noted during the visual inspection of this area are described in the following list.

The inactive disposal area noted on Sheet 1 in Appendix A generally consists of approximately 18 acres across the top of the central portion of the landfill. This area has not yet been filled to the approved final grades, although it has been covered with an intermediate soil cover and vegetated until filtercake placement resumes. Items noted during the visual inspection of this area are described in the following list.
