## **VISUAL SITE INSPECTION REPORT – 2020**

SOUTHERN INDIANA GAS AND ELECTRIC  
A. B. BROWN GENERATING STATION  
TYPE III RESTRICTED WASTE LANDFILL  
WEST FRANKLIN, IN

ATC PROJECT NO. 170LF00979

JANUARY 8, 2021

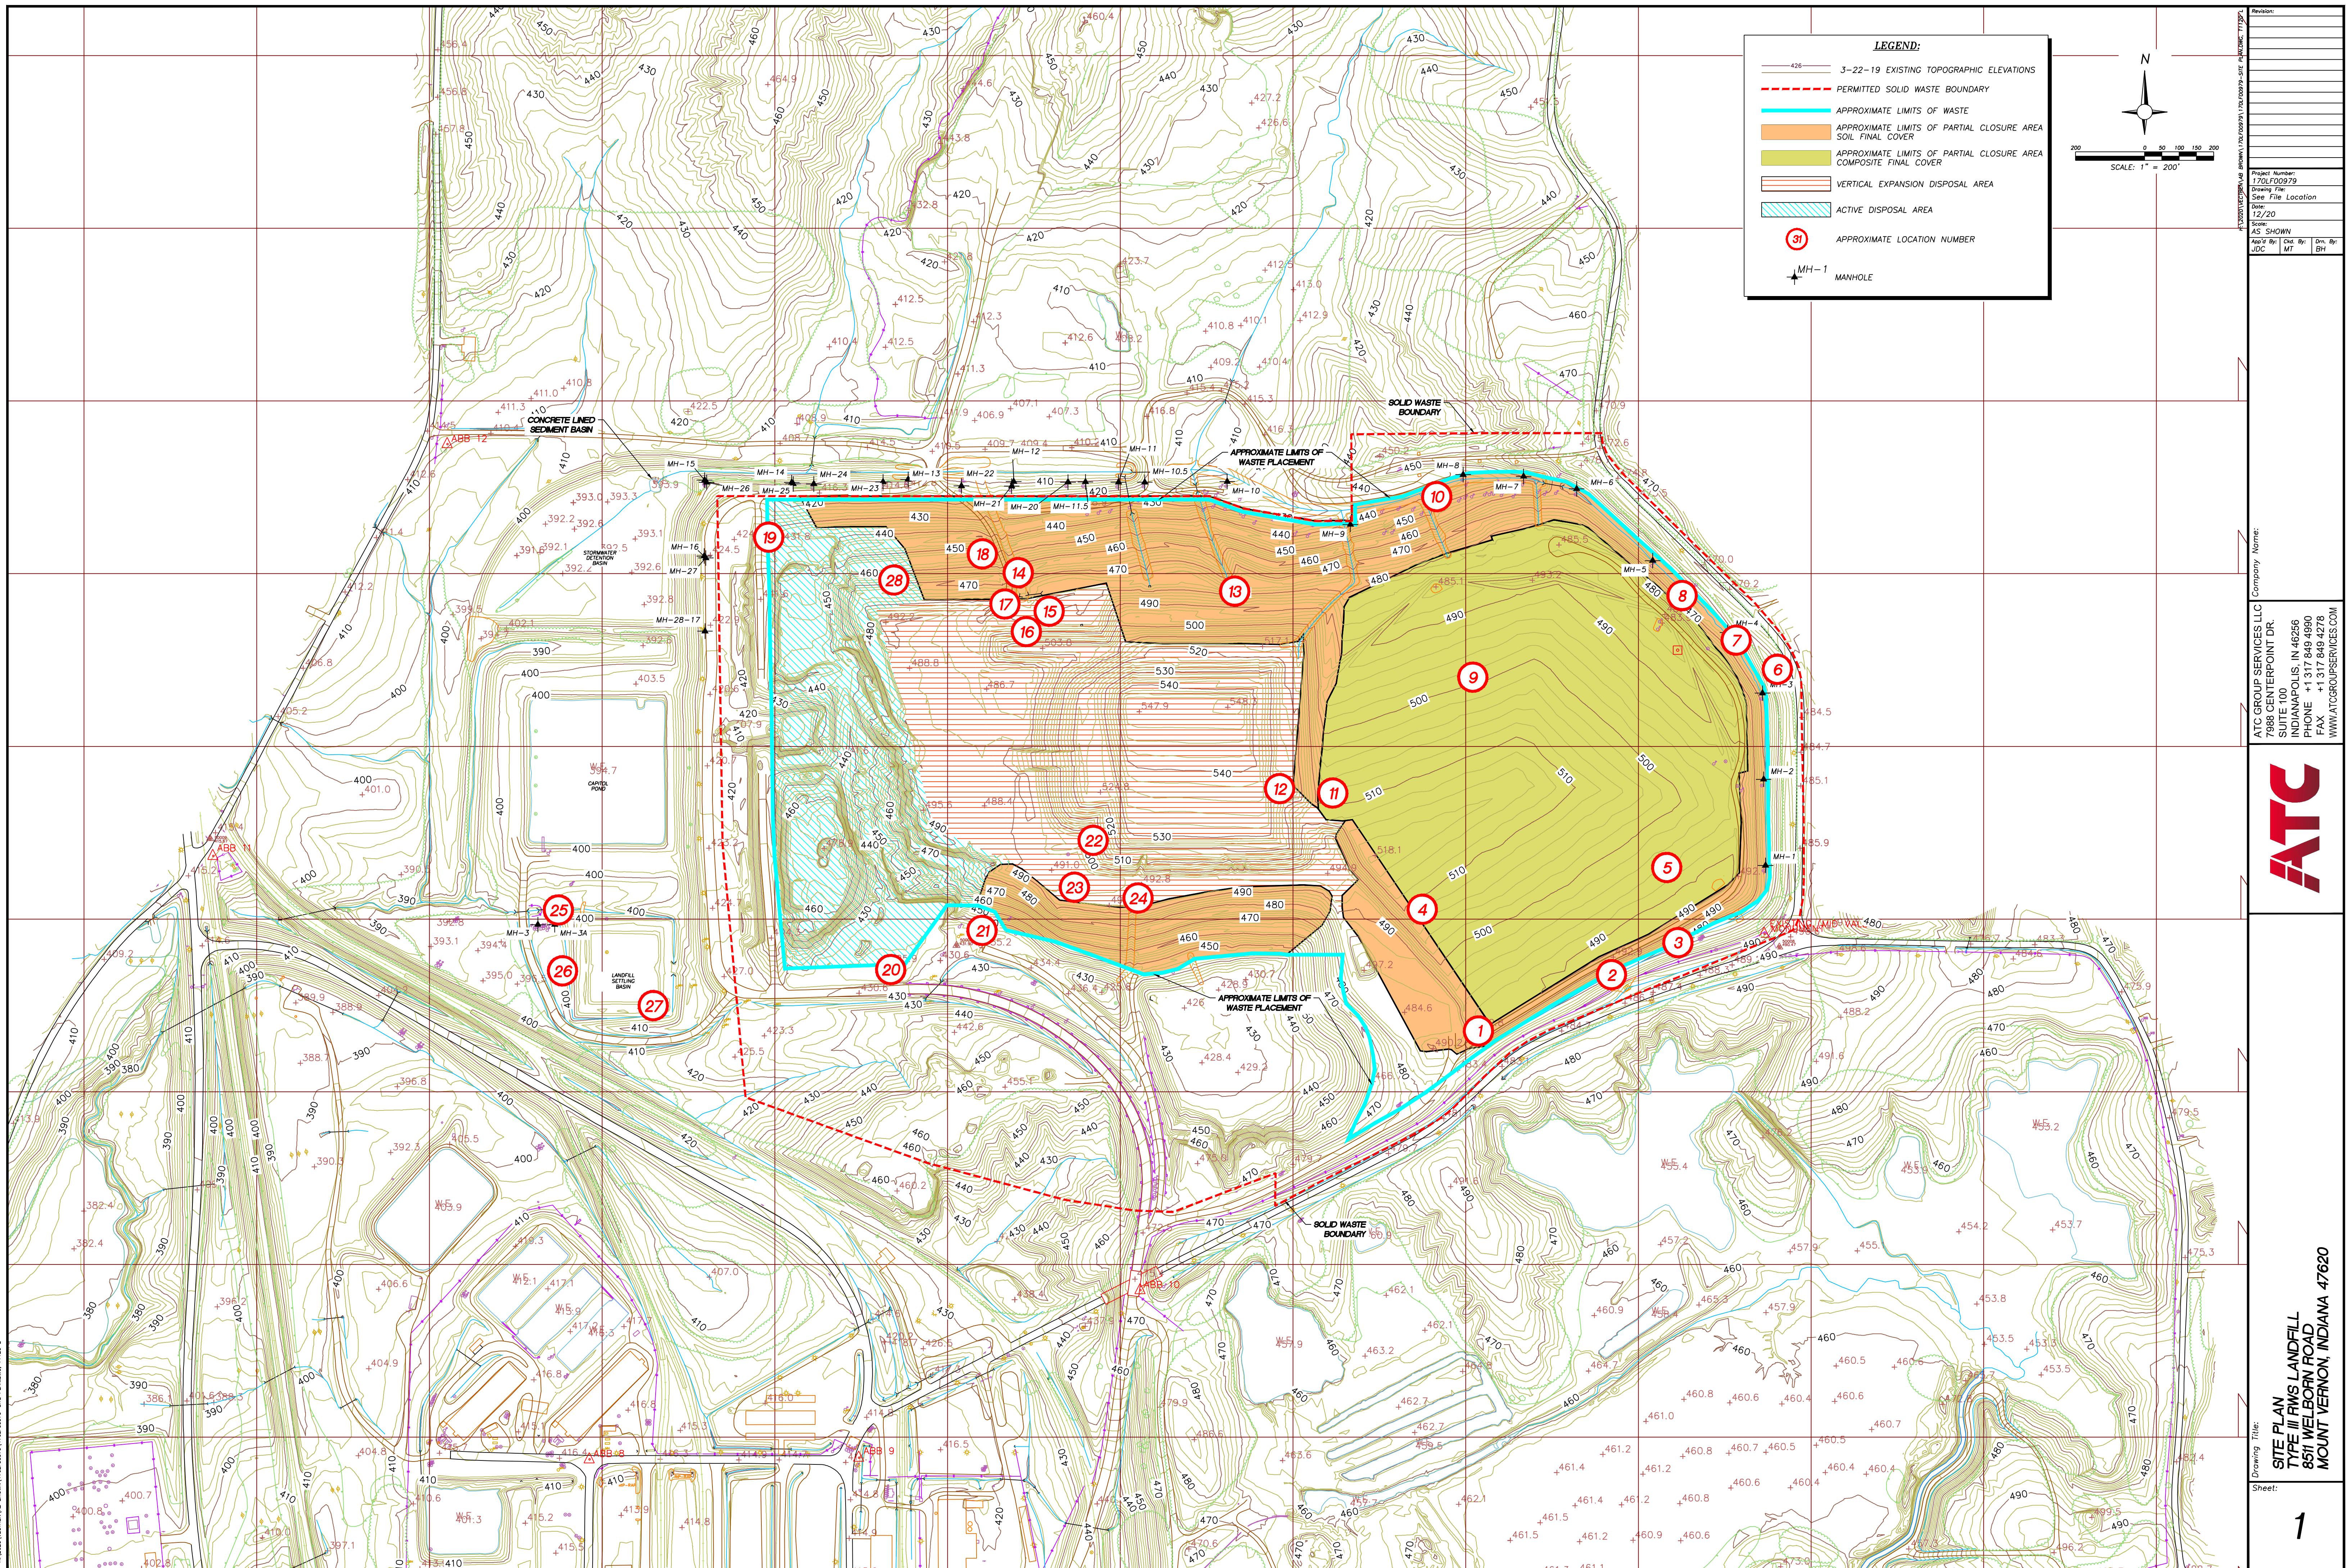
## Appendix A: Site Plan

- 1) In general, this area is well vegetated and well maintained (Locations 1 and 11). No concerns exist at this time.

- 2) Observed erosion occurring along perimeter drainage swale to the south and east of the Partial Closure Areas (Locations 2 and 7).

- 3) Observed sparse vegetation around monitoring wells and other areas located on perimeter drainage swale (Locations 3, 4, and 10).

- 4) The drop inlets and outlet pipes located in the southeast corner of the landfill were generally free of debris at the time of the inspection (Location 5).

- 5) A piezometer located along drainage swale to the east of the Partial Closure Area has been damaged (Location 6).

- 6) Observed rocks blocking entrance to pipe outlet at drainage swale east of Partial Closure Area. (Location 8).

- 7) Observed that at outlet pipe the coupler band has come undone and the ends of the HDPE storm pipe have separated (Location 13).

- 8) Downdrain riprap channel on the north side of the Partial Closure Area appears in good condition and riprap has been reinforced with the addition of chain link fencing fabric (Location 14).

- 9) Observed downdrain pipe entrance collapsed, and accumulation of sediments deposits due to soil erosion (Location 18).

- 1) Observed sparse vegetation around side slopes areas located on the east side of the Vertical Expansion Disposal Area (Location 11).

- 2) Erosion rills have formed on the side slopes of the Vertical Expansion Disposal Area (Locations 12, 15, and 16).

- 3) Erosion gullies have formed on the side slopes of the Vertical Expansion Disposal Area (Location 22).

- 4) Observed vehicle tracks and ruts formed on terrace section of the Vertical Expansion Disposal Area (Location 23).

- 5) Observed soil erosion of landfill sideslope at pipe outlet, and lack of riprap at downchute on the south side of Vertical Expansion Disposal Area (Location 24).

- 1) Active filling is ongoing at the west end of the landfill (Location 28).

- 2) There is a limited amount of freeboard between the surface of the waste and the adjoining access road at the south end of the Active Landfill Area (Location 20). In addition, surface water runoff from the northern portion of the Active Landfill Area is routed to a depression with limited freeboard at the far north end (Locations 19). It should be noted that the available freeboard at Location 19 has been improved compared to previous inspections.

- 3) Observed the presence of filter cake and soft saturated soils on the south side of the active disposal area (Location 21).

- 1) Observed rock inside storm pipe entrance, and soil erosion in front of pipe (Location 25).  
**Recommendation:** Remove rock and stabilize pipe entrance with riprap to help prevent erosion.
- 2) Grass swale west of Landfill Settling Pond appears to be working properly, adequately conveying the site drainage downstream (Location 26).  
**Recommendation:** None at this time.
- 3) The slopes of the Settling Basin are lined with riprap and appeared in satisfactory condition. Also, the pond is maintaining adequate freeboard (Location 27).  
**Recommendation:** Continue to monitor the condition of the pond and perform maintenance as necessary.

**Recommendation: Install riprap around outfall pipe, and erosion control blankets (ECB's) to prevent further erosion at these areas.**

**Recommendation: Areas of sparse vegetation should be reseed with similar grasses to the ones at the site, and temporarily isolated to prevent trampling and help re-establish grass cover.**

**Recommendation: Replace damaged piezometer.**

**Recommendation: Remove rocks from pipe outlet.**

**Recommendation: Fix pipe connection.**

**Recommendation: Fix pipe entrance and stabilize the adjacent area with erosion control blankets, riprap, to prevent further erosion.**

**Recommendation: Repair rills, install erosion control blankets and/or other erosion BMPs, and reseed areas to re-establish grass cover on the side slopes.**

**Recommendation: Repair gullies, install erosion control blankets and/or other erosion BMPs, and reseed areas to re-establish grass cover on the side slopes.**

**Recommendation: Reinforce path section to accommodate vehicle travel, allowing for proper drainage conveyance.**

**Recommendation: Reinforce downstream side of pipe crossing with riprap, connecting it to downchute section.**

**Recommendation: Monitor these areas during and after significant storm events to maintain adequate freeboard.**

**Recommendation: Check the water levels in nearby piezometers and determine the source of the water and filter cake.**
