Submitted to
Southern Indiana
Gas & Electric Company
(SIGECO)
dba CenterPoint Energy
Indiana South
211 Northwest Riverside
Drive, Evansville, IN 47708

Submitted by
AECOM
9400 Amberglen Boulevard
Austin, Texas 78729

October 13, 2021

CCR Certification:
Structural Stability Assessment
§257.73 (d)
for the
East Ash Pond
at the
F. B. Culley Generating Station
Revision 0

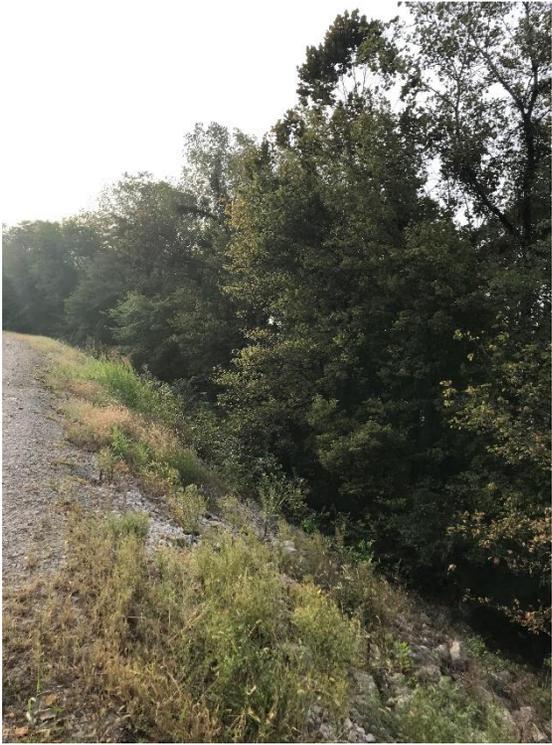
Photo No. 1	Date: 10/11/2021

Location: F.B. Culley Generating Station		
Description: Standing at the west end of southern dike, looking east. Picture shows slope protection of southern dike. Photographer: Ben Arnett		
Photo No. 2	Date: 10/11/2021

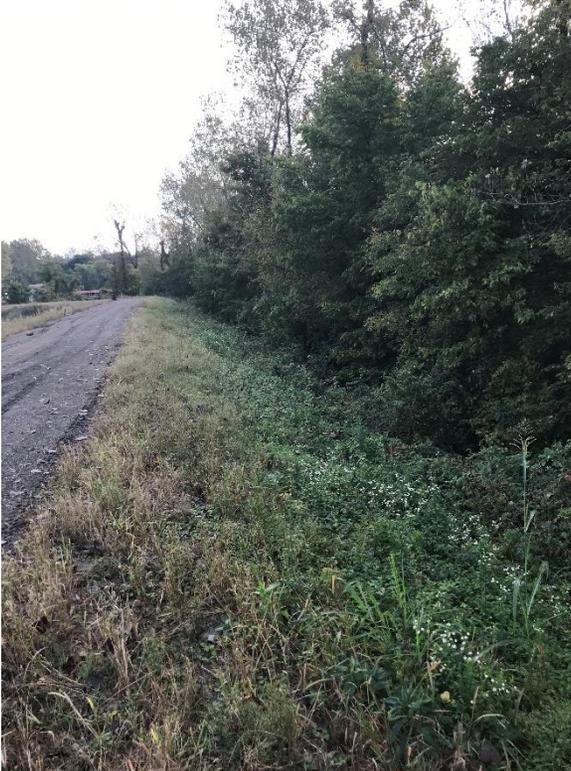
Location: F.B. Culley Generating Station		
Description: Standing midway along southern dike, looking downslope. Photographer: Ben Arnett

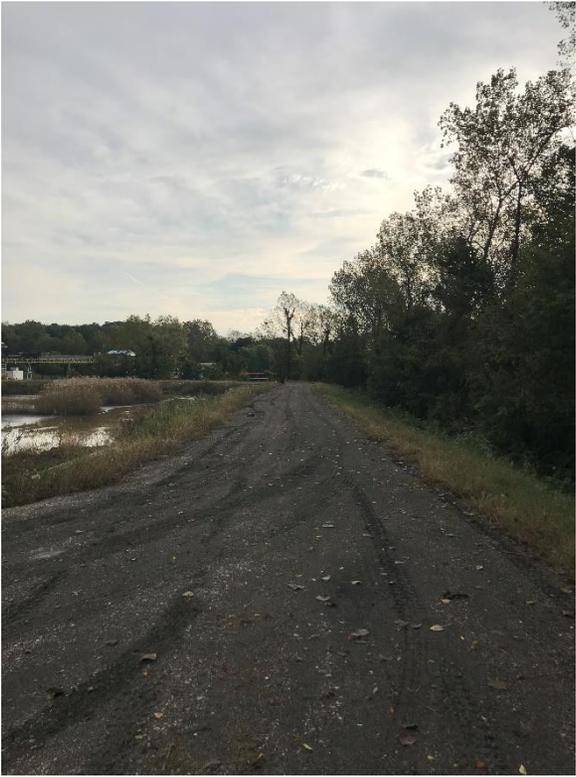
<p>Photo No. 3</p>	<p>Date: 10/11/2021</p>

<p>Location: F.B. Culley Generating Station</p>		
<p>Description: Standing midway along southern dike, looking east. Picture shows slope protection. Photographer: Ben Arnett</p>		
<p>Photo No. 4</p>	<p>Date: 10/11/2021</p>

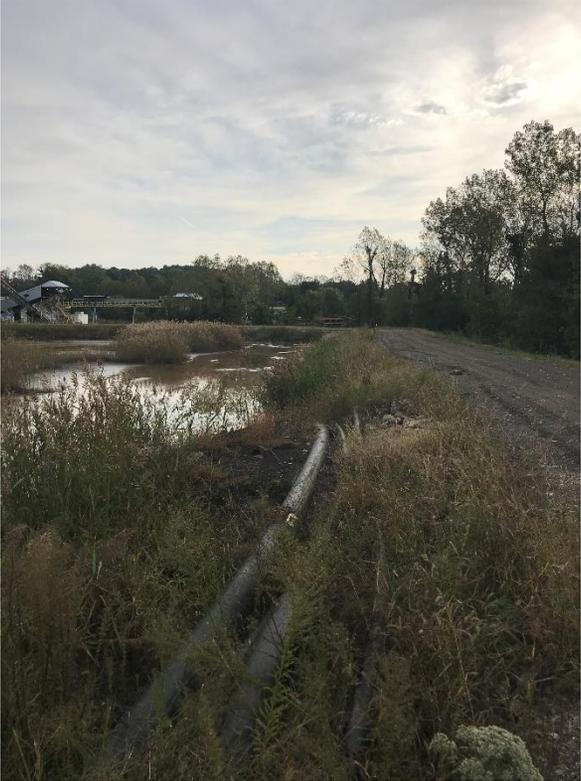
<p>Location: F.B. Culley Generating Station</p>		
<p>Description: Standing midway along southern dike, looking back over surface impoundment. Picture shows stability of northern dike into surface impoundment. Photographer: Ben Arnett</p>

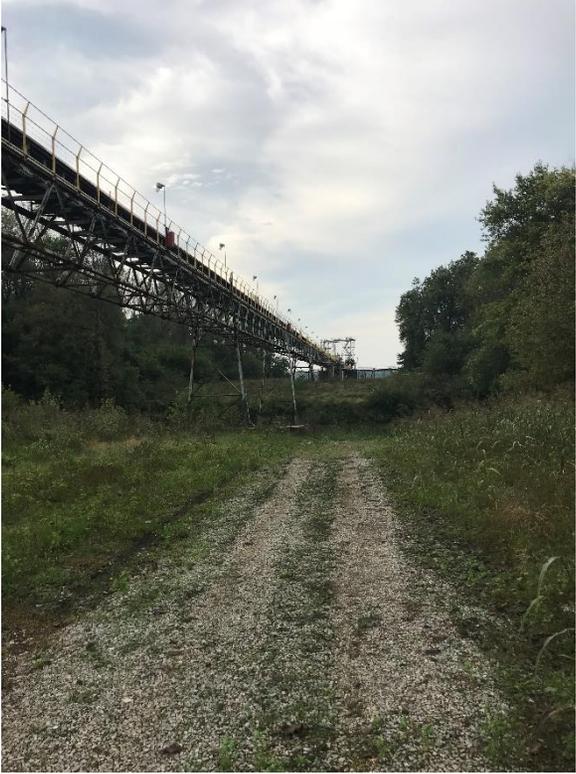
<p>Photo No. 5</p>	<p>Date: 10/11/2021</p>

<p>Location: F.B. Culley Generating Station</p>		
<p>Description: Standing along the toe of the east side of the impoundment, looking south. Picture shows adequate slope protection and no evidence of seepage. Photographer: Ben Arnett</p>		
<p>Photo No. 6</p>	<p>Date: 10/11/2021</p>

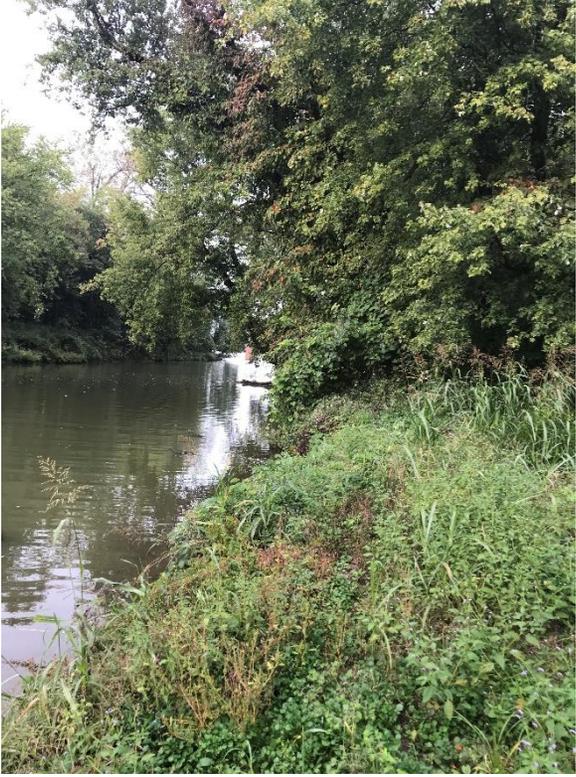
<p>Location: F.B. Culley Generating Station</p>		
<p>Description: Standing on the exterior toe of the south side of the impoundment, adjacent to Little Pigeon Creek. Picture shows adequate slope protection and no evidence of seepage or sloughing on the exterior slope of the dike. Photographer: Ben Arnett</p>

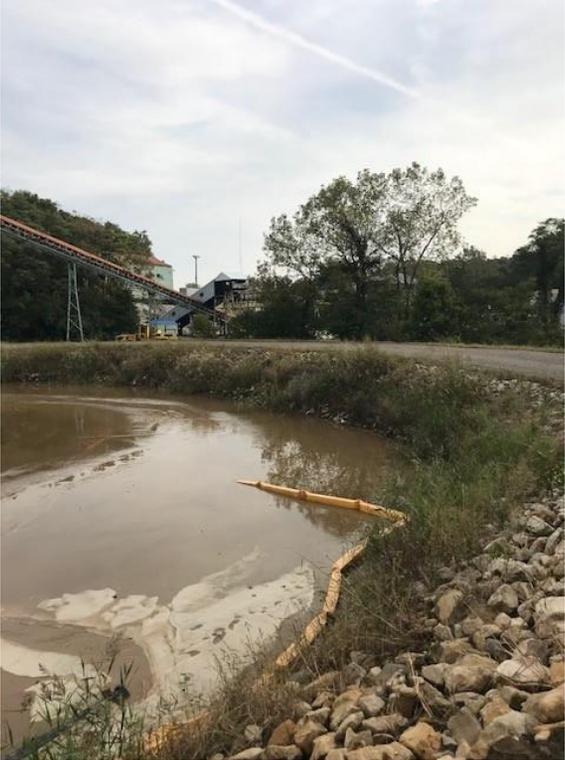
Photo No. 7	Date: 10/11/2021

Location: F.B. Culley Generating Station		
<p>Description: Standing on the southeast corner of the dike looking at the interior of the impoundment.</p> <p>Picture shows riprap slope protection on the interior slope of the impoundment.</p> <p>Photographer: Ben Arnett</p>
