July 17, 2020

CCR Annual Inspection

West Ash Pond

F. B. Culley Generating Station

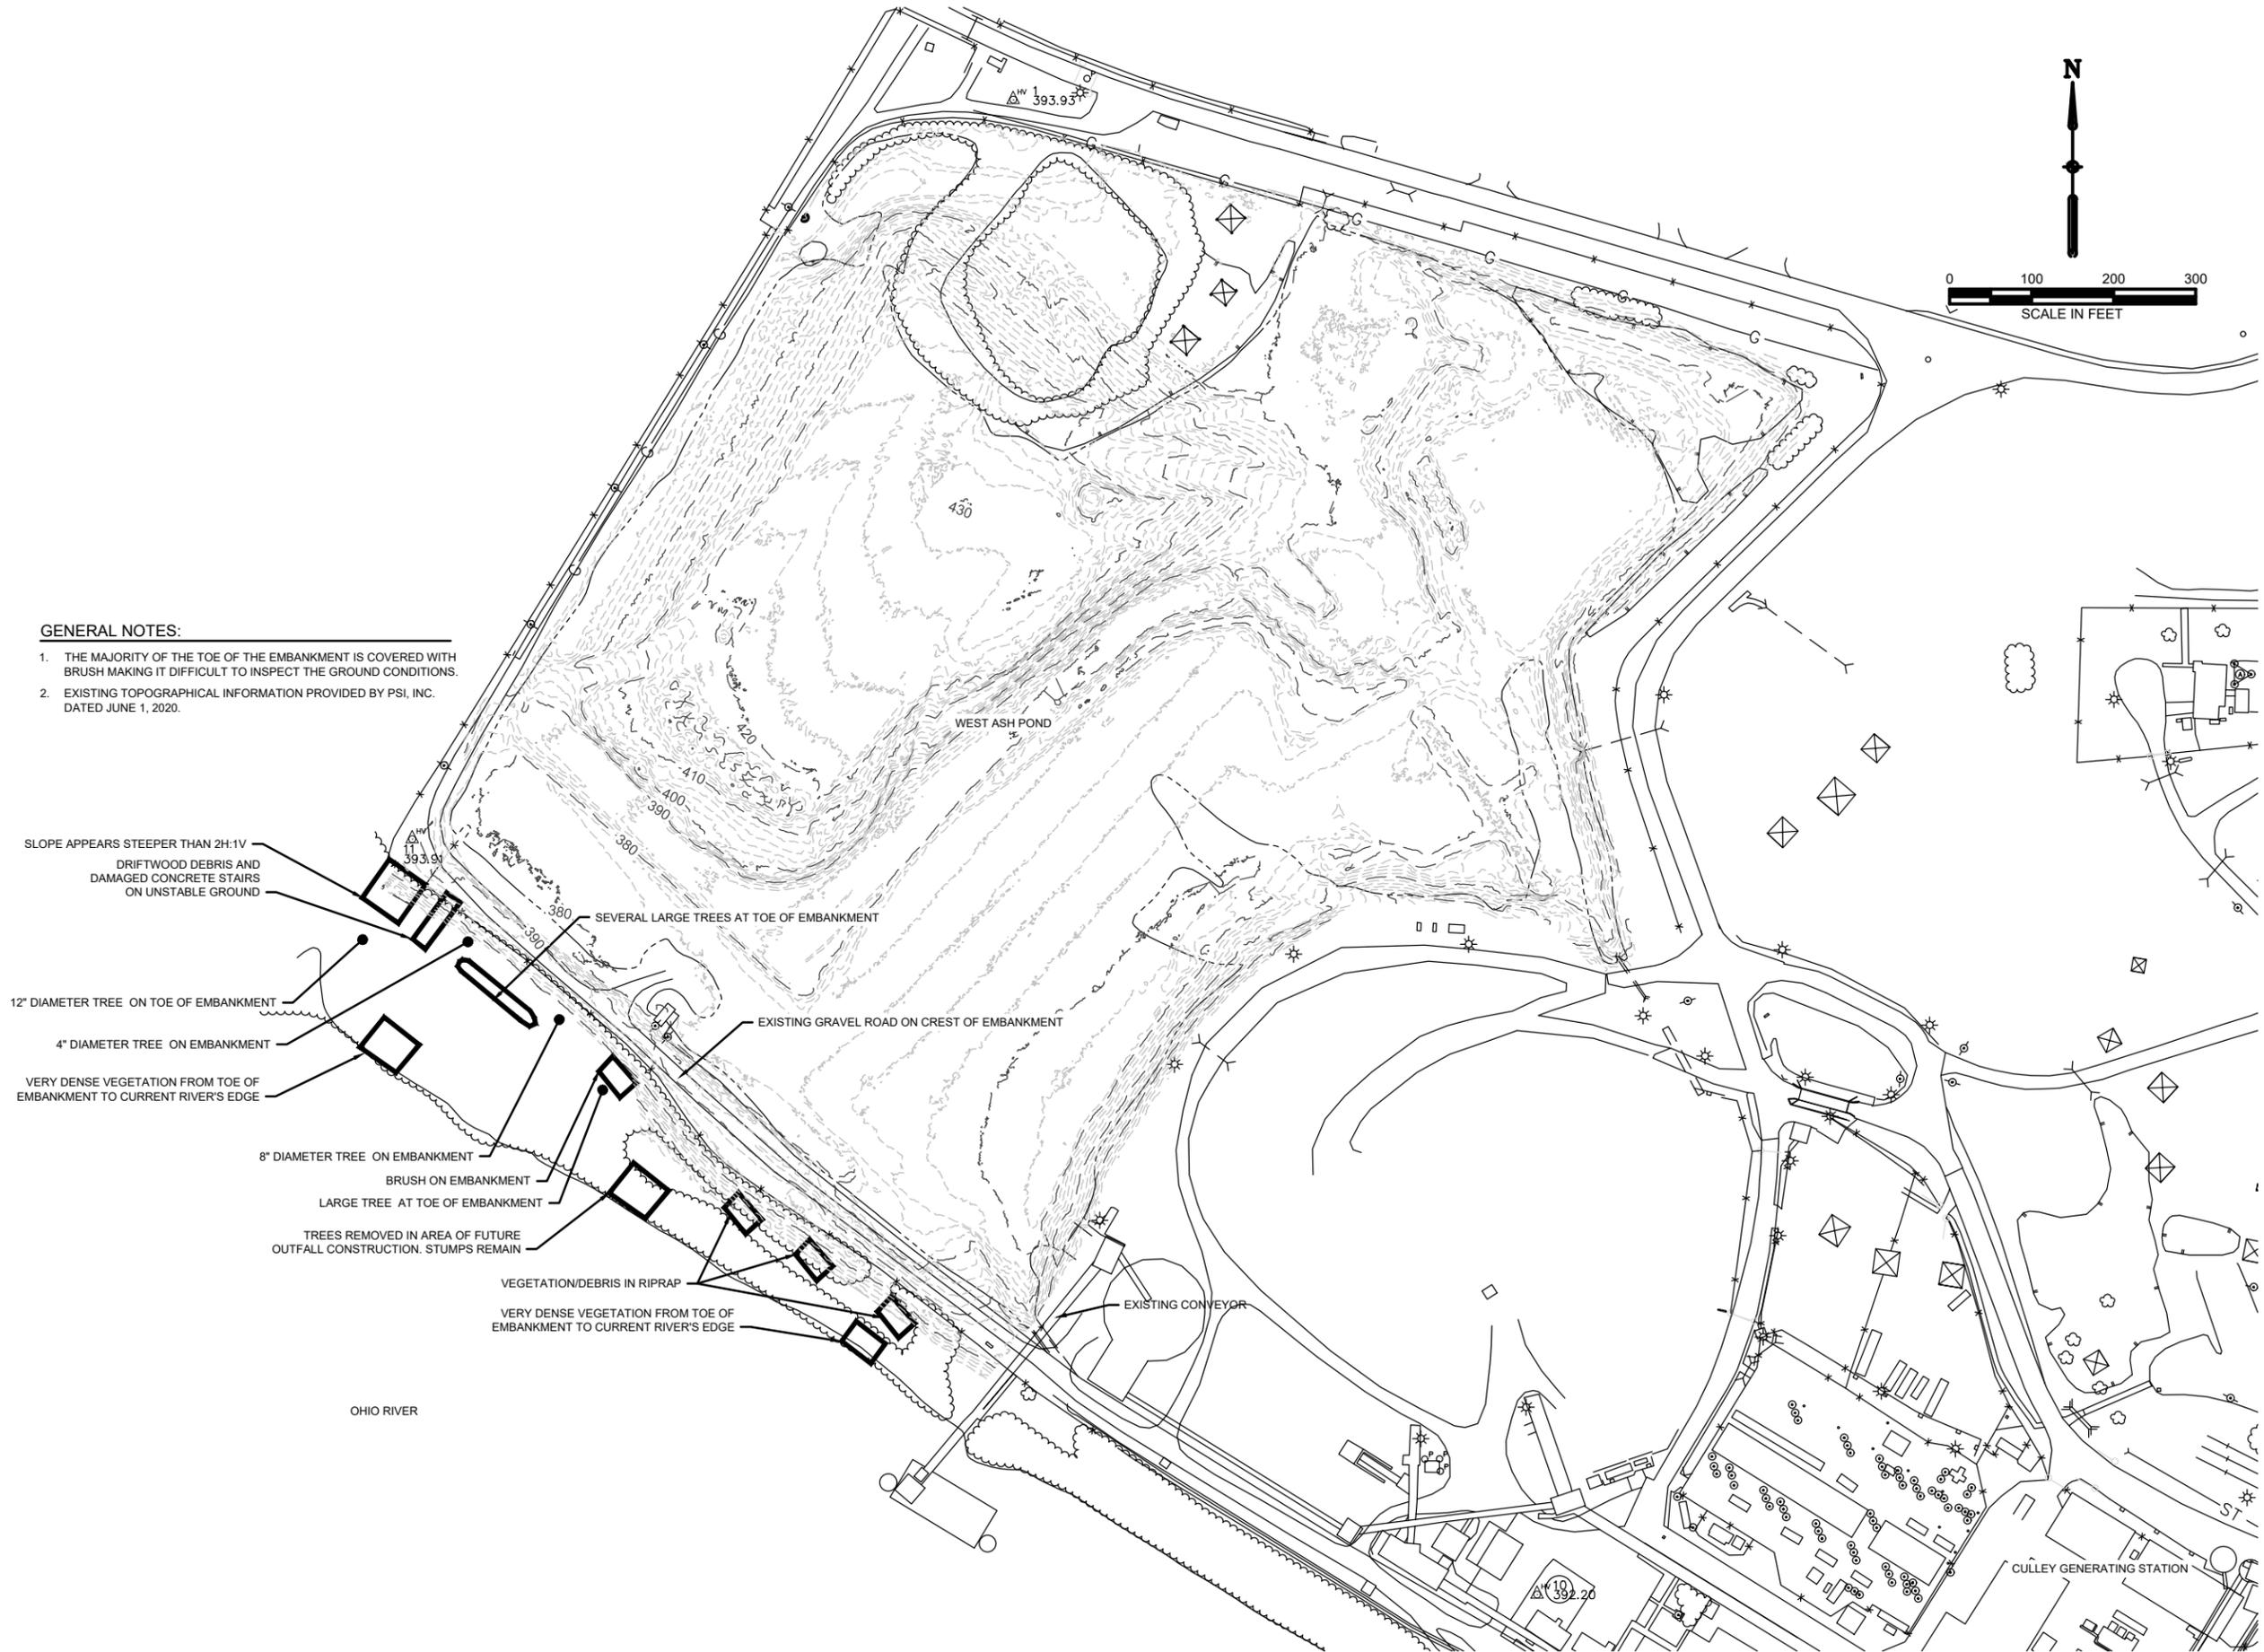
FIGURE 3

Table 2-3 – Areas of Concern (Current Inspection: June 12, 2020)	
Deficiency/Observation	Proposed Corrective Measure
Exterior Slope – A few small trees/bushes and brush have grown on the embankment slope.	Continue monitoring. Cut small trees/bushes to a level flush with the ground surface (so as to not disturb the subsurface) and spray remaining vegetation ¹ .

<p>Exterior Slope – Concrete stairs leading to the Ohio River are damaged and unsafe. Unstable terrain underlies collapsing stairs.</p>	<p>Do not use damaged stairs. Remove or repair stairs as part of the closure construction, which will also include regrading and stabilization of this area as necessary¹.</p>
<p>Exterior Slope – Small animal burrows were observed on the top of the embankment slope.</p>	<p>Address when lowering the embankment which is planned as part of the closure construction.</p>
<p>Toe of Embankment Slope – There are several large trees and overgrown brush at the toe of slope, along the edge of the Ohio River.</p> <p>[The majority of the trees on the downstream slope of the embankment are at the toe and no seepage was observed in this area. No visual evidence was observed of stability concerns (i.e., sloughing, depressions, erosion, etc.)]</p>	<p>Additional vegetation removal will be performed as part of embankment lowering for the closure construction. Continue monitoring until closure construction is complete. As noted in the previous inspection report, based on the size and extent of the trees, AECOM believes removing these trees prior to the lowering of the embankment as part of the closure construction would result in significant disturbance to the unit, which could destabilize the embankment and could promote excessive erosion during high rainfall events. It is our opinion that the trees are currently necessary for stabilization of the embankment and are better left in place.</p> <p>Monitor brush and spray/remove if it continues to encroach onto embankment slope.</p>

SLOPE APPEARS STEEPER THAN 2H:1V
DRIFTWOOD DEBRIS AND
DAMAGED CONCRETE STAIRS
ON UNSTABLE GROUND

SEVERAL LARGE TREES AT TOE OF EMBANKMENT

12" DIAMETER TREE ON TOE OF EMBANKMENT

4" DIAMETER TREE ON EMBANKMENT

VERY DENSE VEGETATION FROM TOE OF
EMBANKMENT TO CURRENT RIVER'S EDGE

8" DIAMETER TREE ON EMBANKMENT

BRUSH ON EMBANKMENT

LARGE TREE AT TOE OF EMBANKMENT

VEGETATION/DEBRIS IN RIPRAP
