CCR Annual Inspection

East Ash Pond

F. B. Culley Generating Station

Revision 0

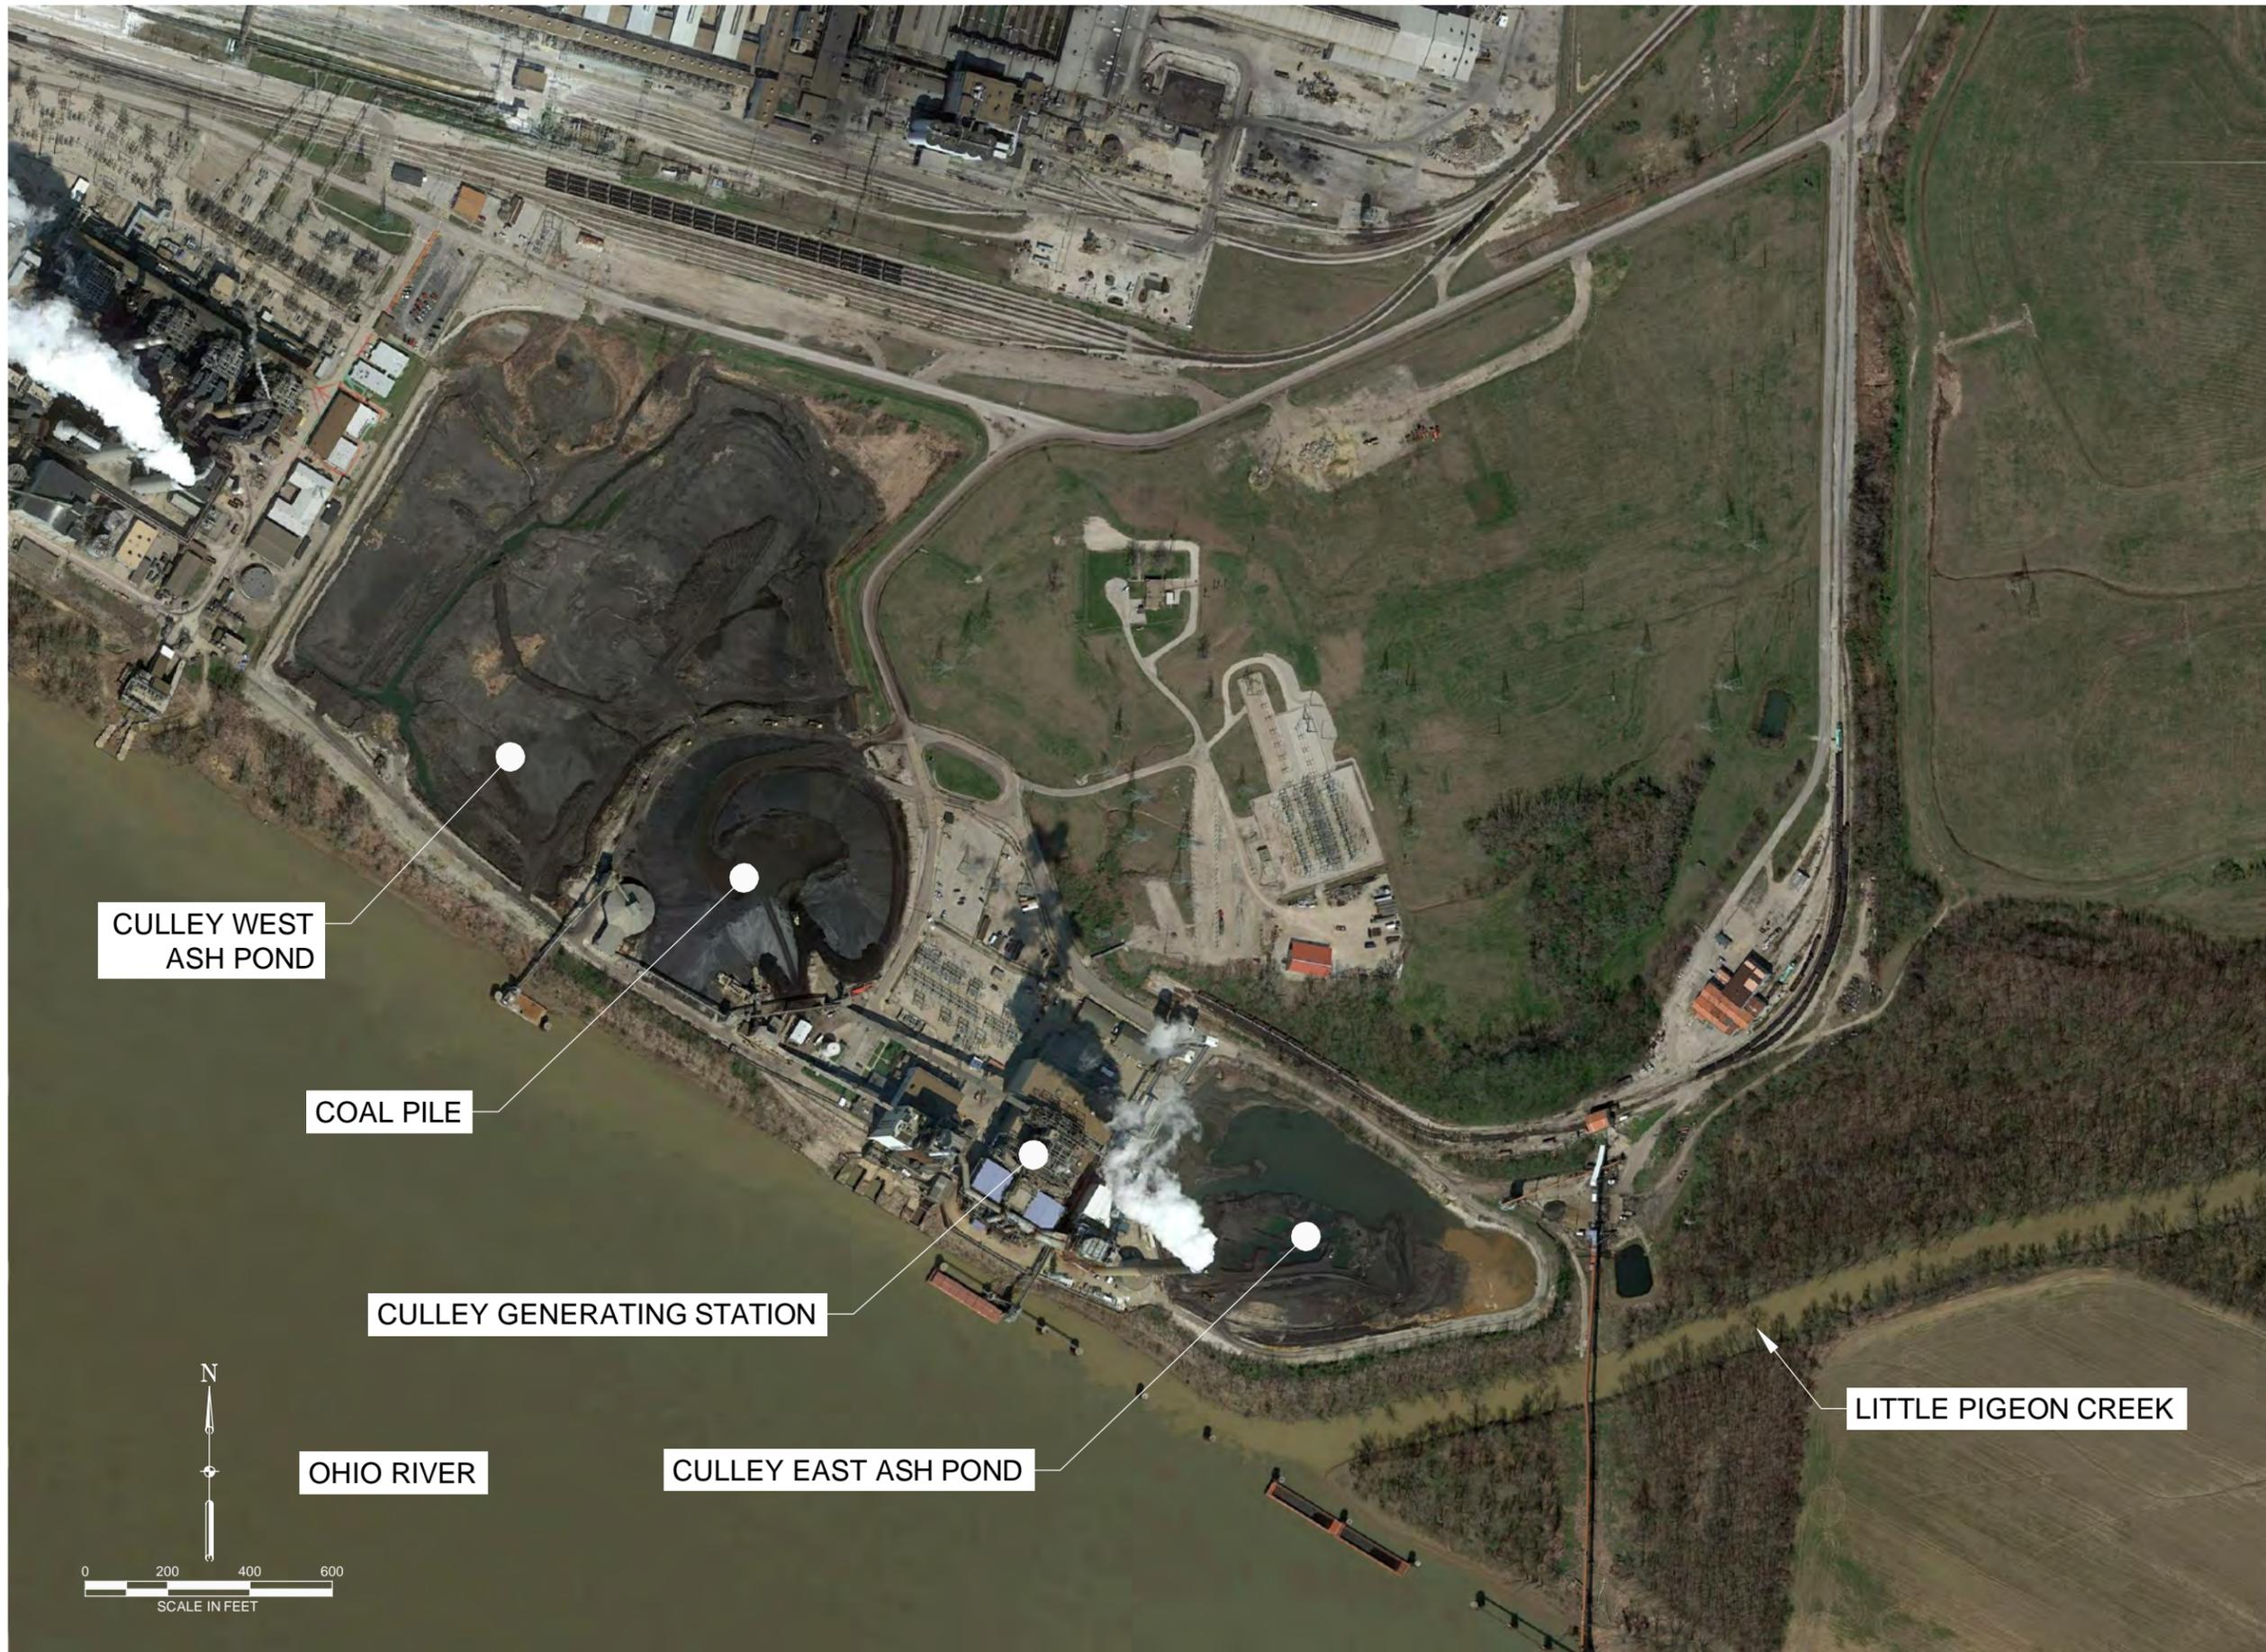
FIGURE 2

Figure 2 – Site Map

A site Location Map showing the area surrounding the station is included as **Figure 1 of Appendix A. Figure 2 in Appendix A** presents the Culley Site Map.

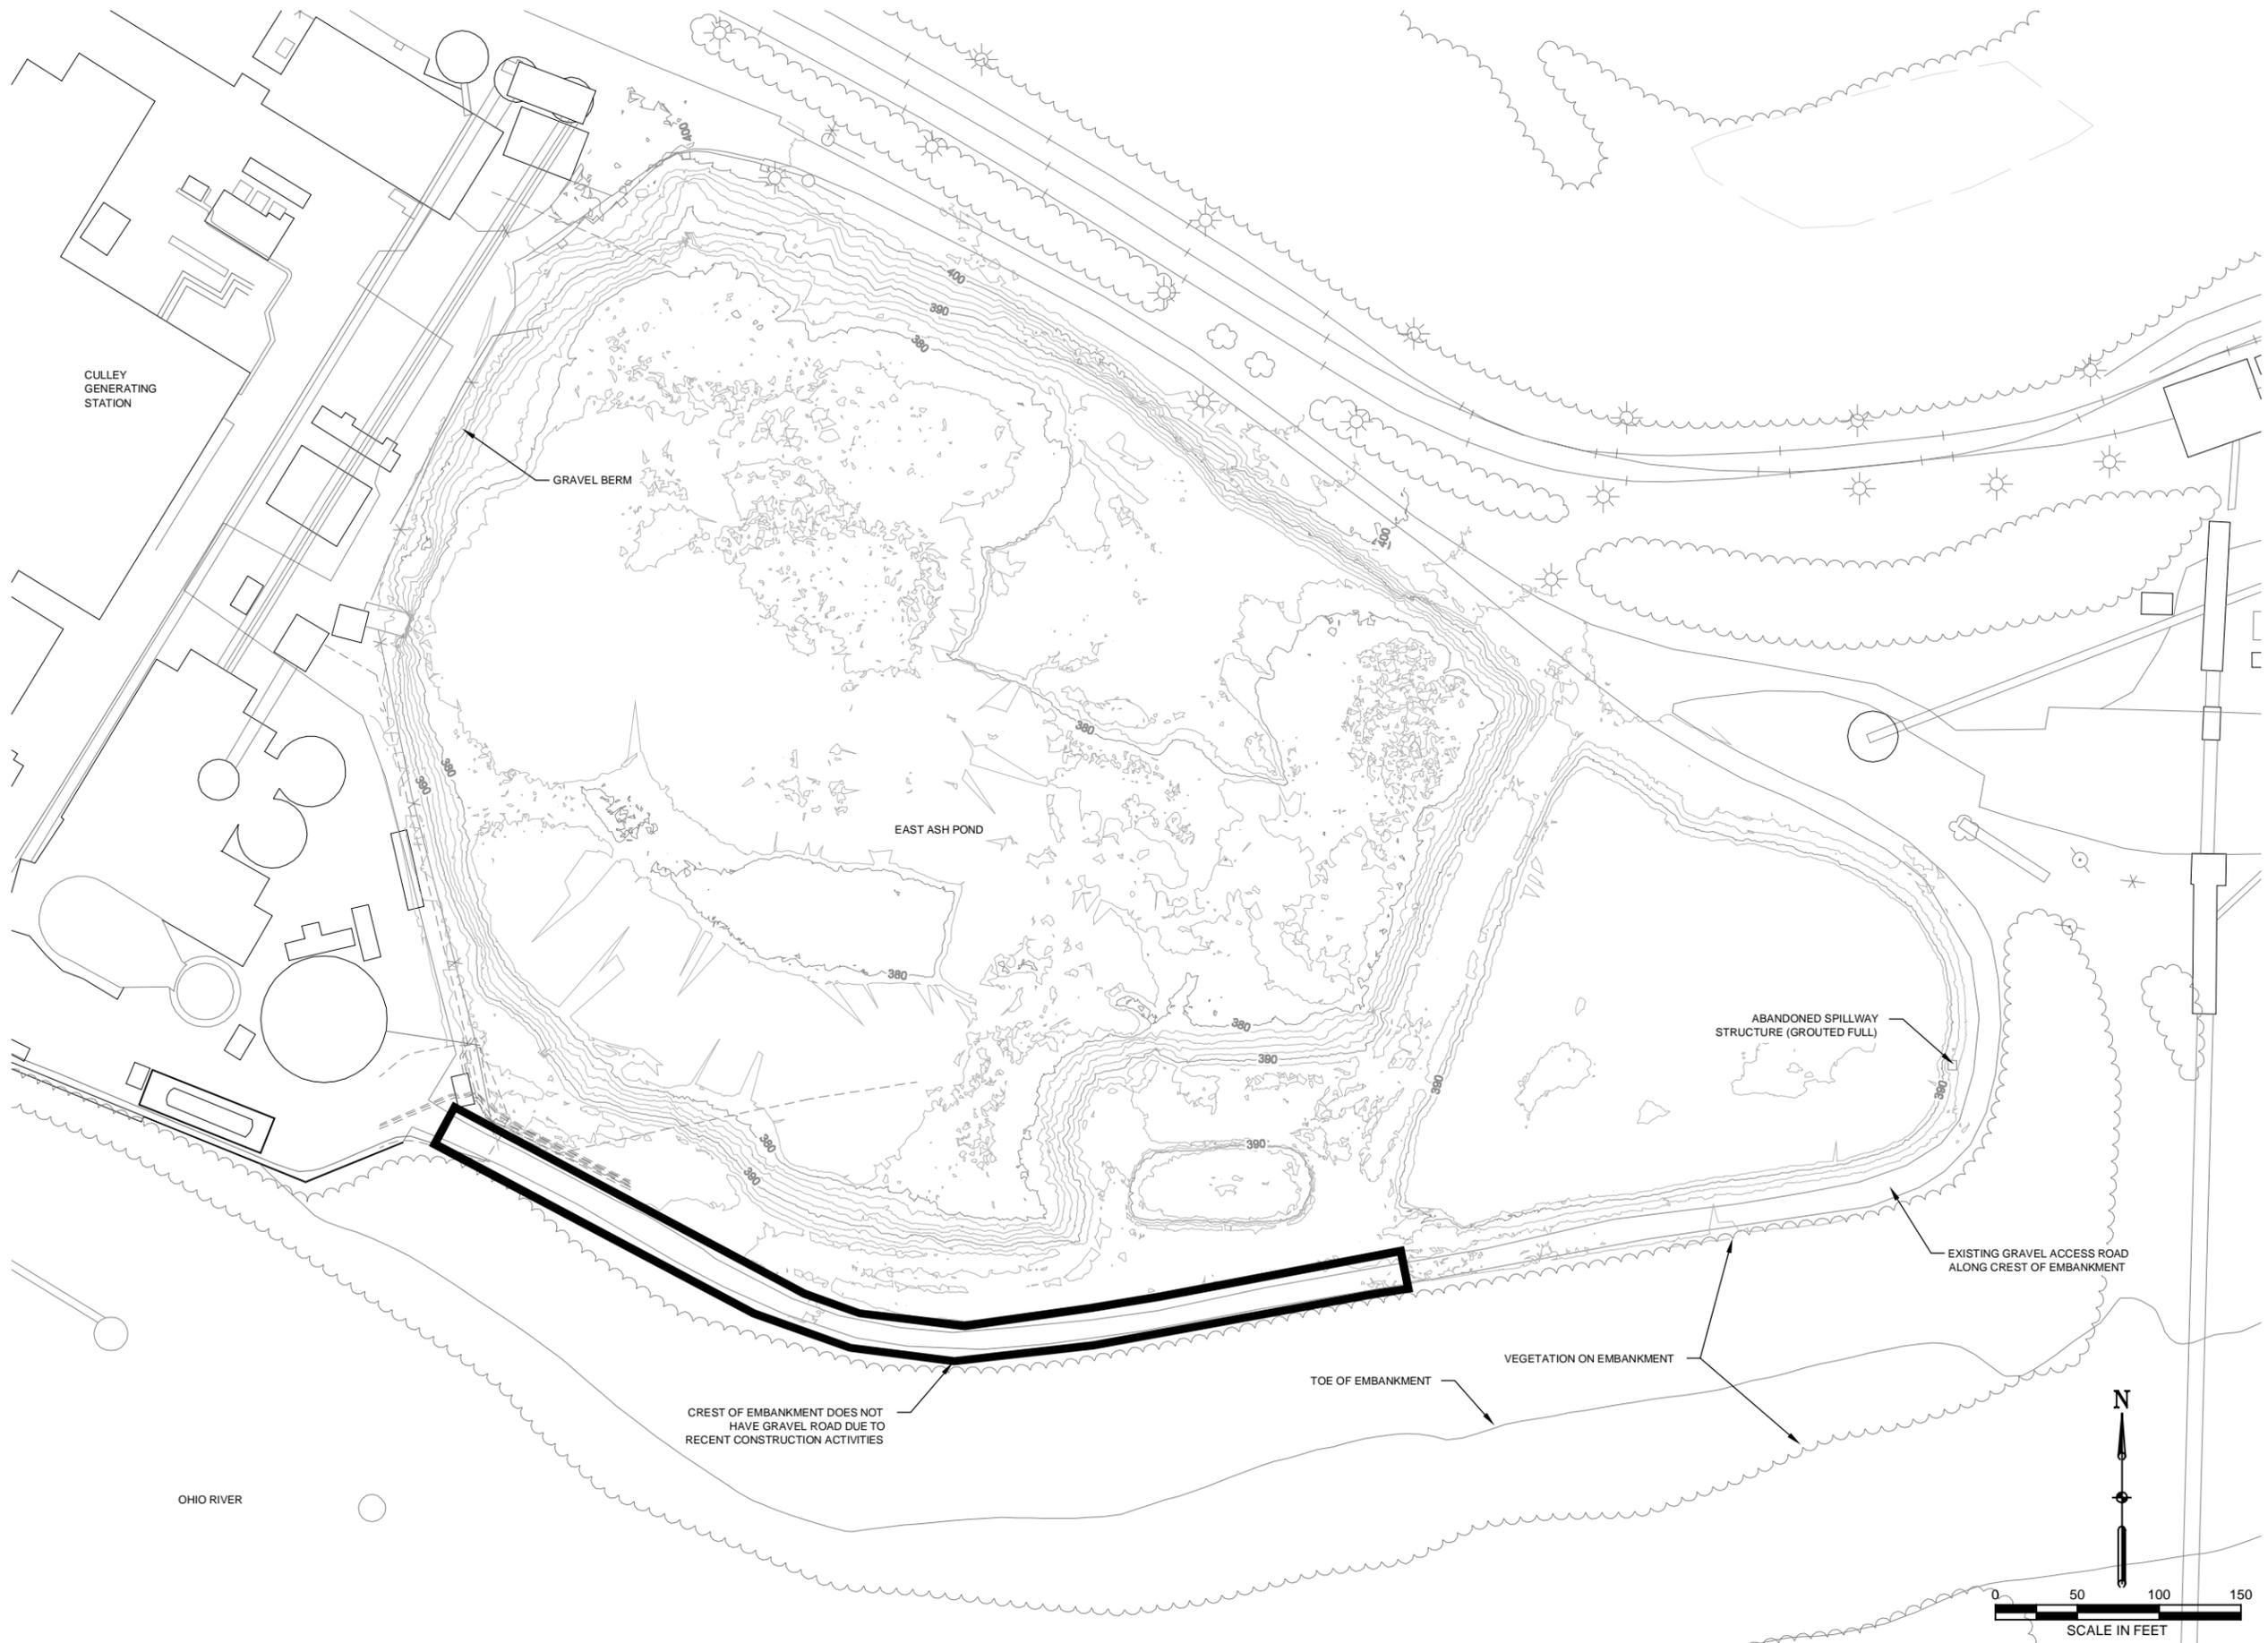
FIGURE 3

INSPECTION SITE PLAN
